# The Canons, Mitcham

Conservation plan - September 2016  
Final issue

Simpson & Brown

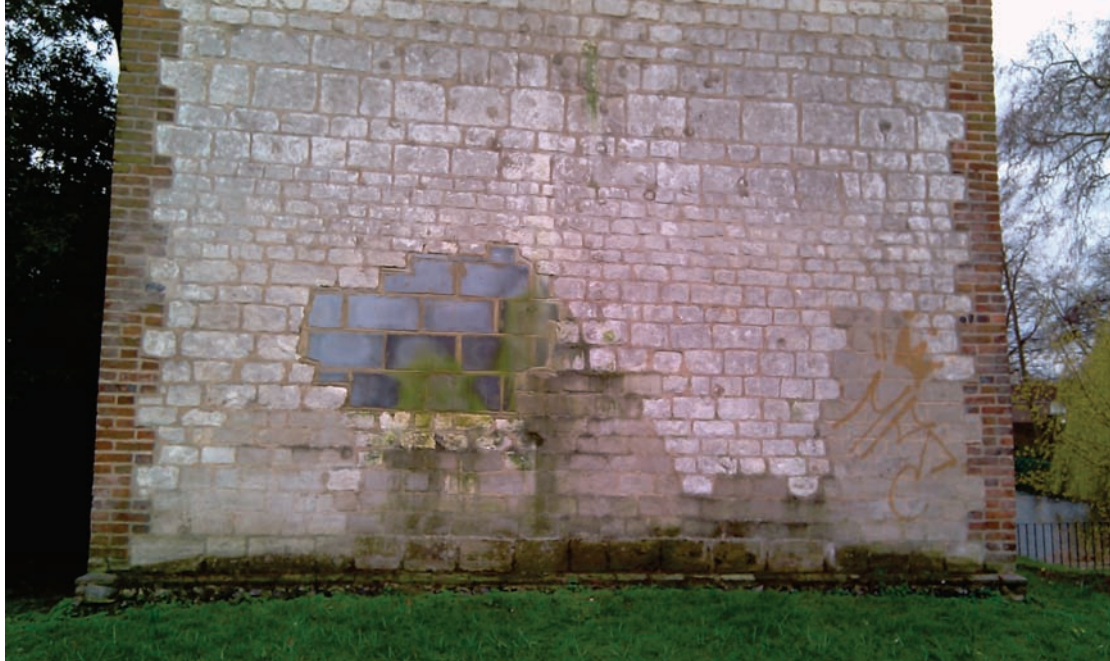
**Figure 27** Photograph of north elevation before repairs in 2011. *Courtesy of Jill Tyndale London Borough of Merton*

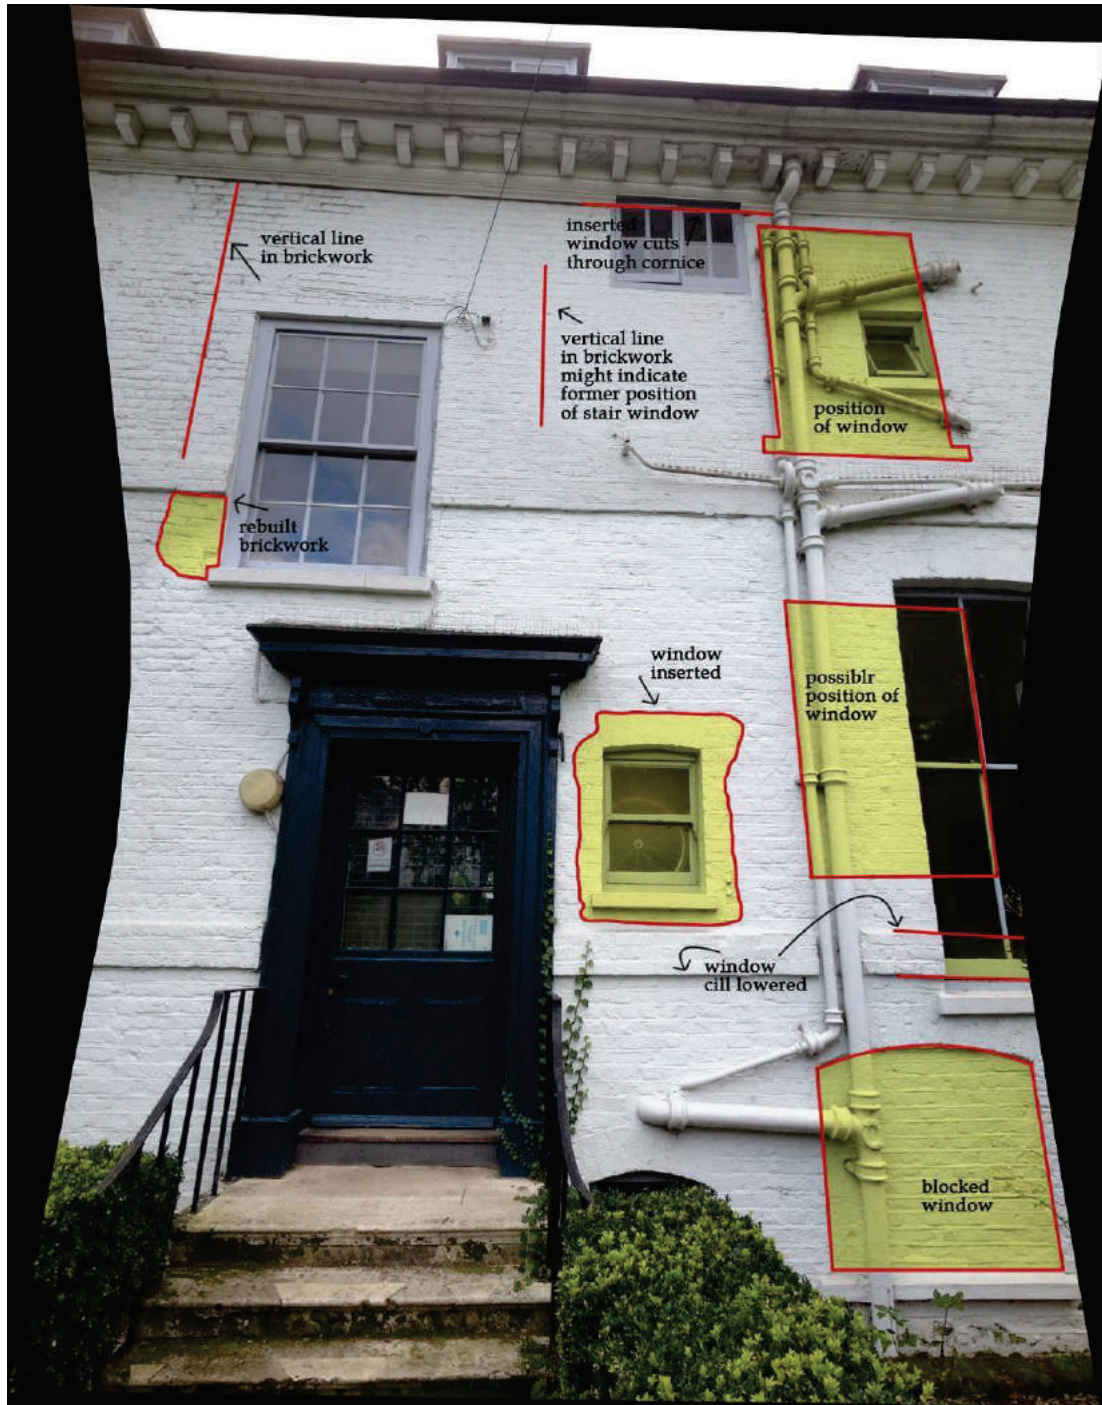
**Figure 30** Composite image of west elevation (north part) annotated.

The window above the doorway is not centred on it. This window would have been moved if the staircase has been changed. Above this window is what appears to be a concrete lintel but a concrete lintel in this position would post-date the assumed date of the change of the stair by 100 years or so. Above the lintel is an area of masonry which appears to have had some rebuilding in the past. This is the roughest area of brickwork on the whole building. It is possible that the concrete lintel is a response to a brick arch or a timber lintel which has failed in the past.

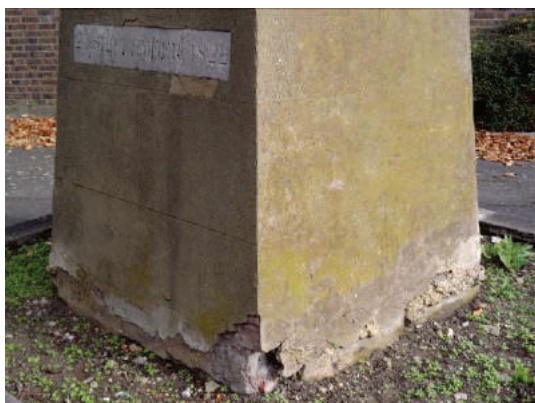
**Figure 42** View of foot of obelisk showing damage to render.

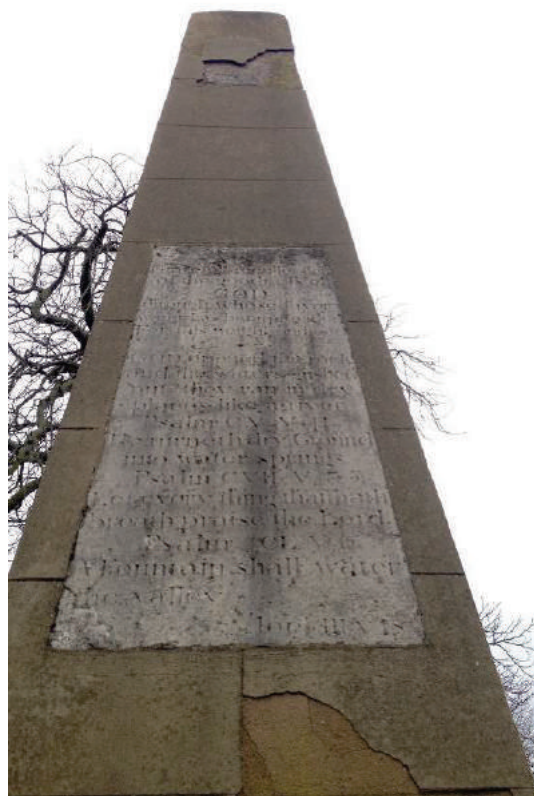
**Figure 43** View of principal plaque-face of obelisk showing areas of failing render.

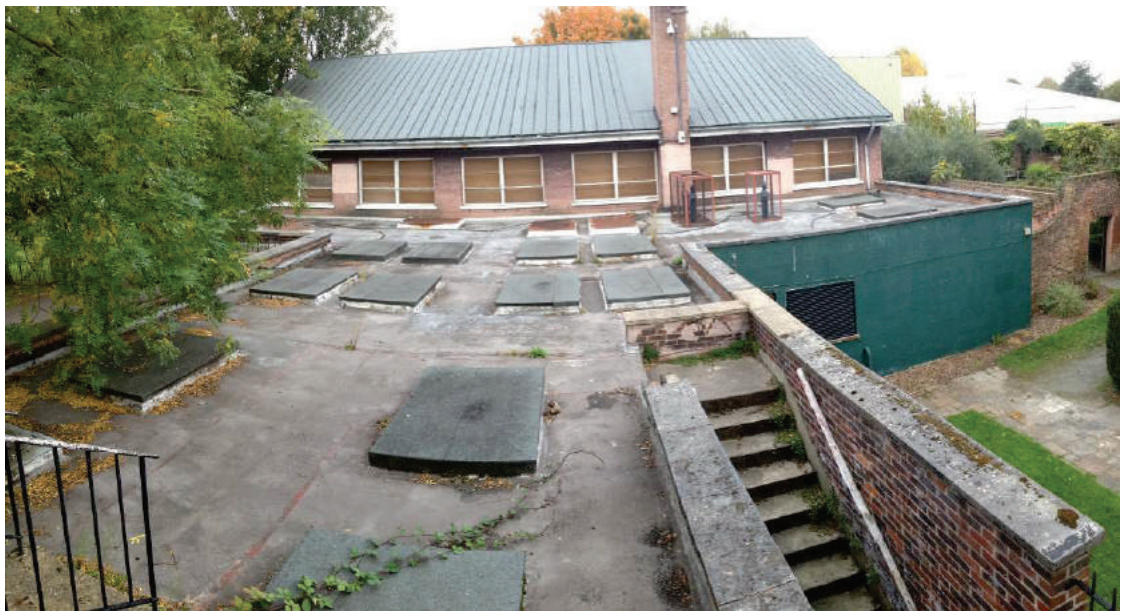
**Figure 49** View looking north from first floor exit of Canons house onto roof of WC extension and Madeira Hall. Skylights have been blocked and covered in bituminous felt.

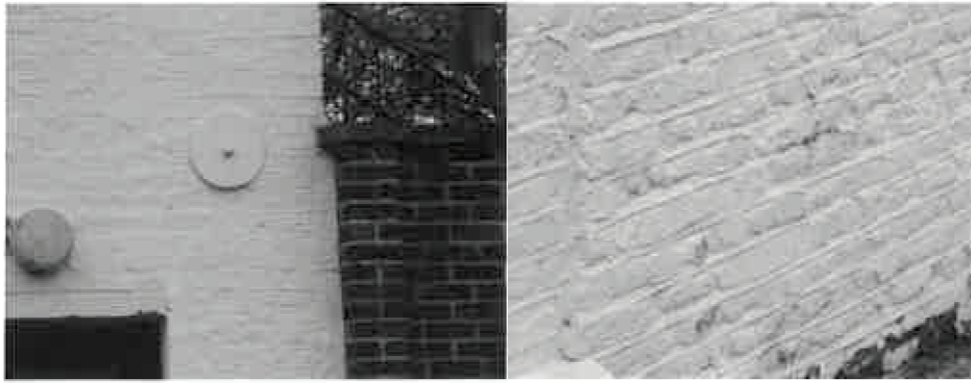
5. Behind the paint there was a build-up of salts which gradually made the paint bubble.

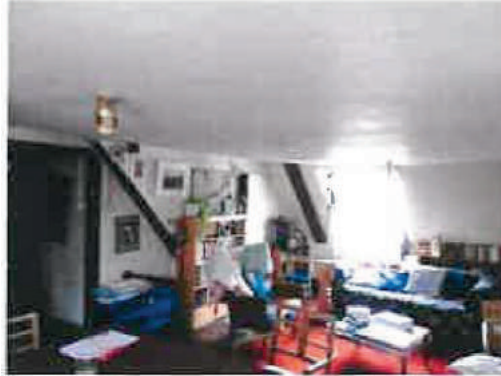
11. There was water staining to the west part of the north wall by the chimney. This staining suggested that the wall was not breathing adequately.

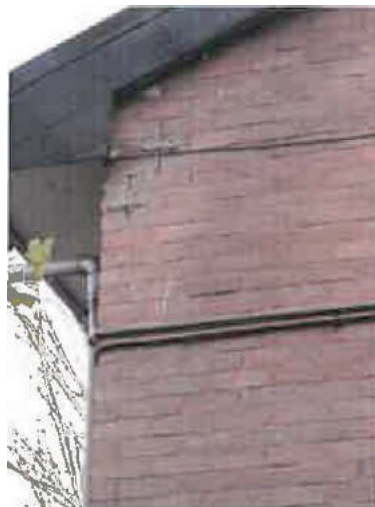
15. At the east end of the building there were significant diagonal cracks in the brickwork suggesting that the soil beneath has failed. The cause of the failure is almost certainly due to a failure of the drains.
