THE CANONS - COMMUNITY ARCHAEOLOGY - CANONS HOUSE

Canons, Mitcham - Opening up works, August 2016

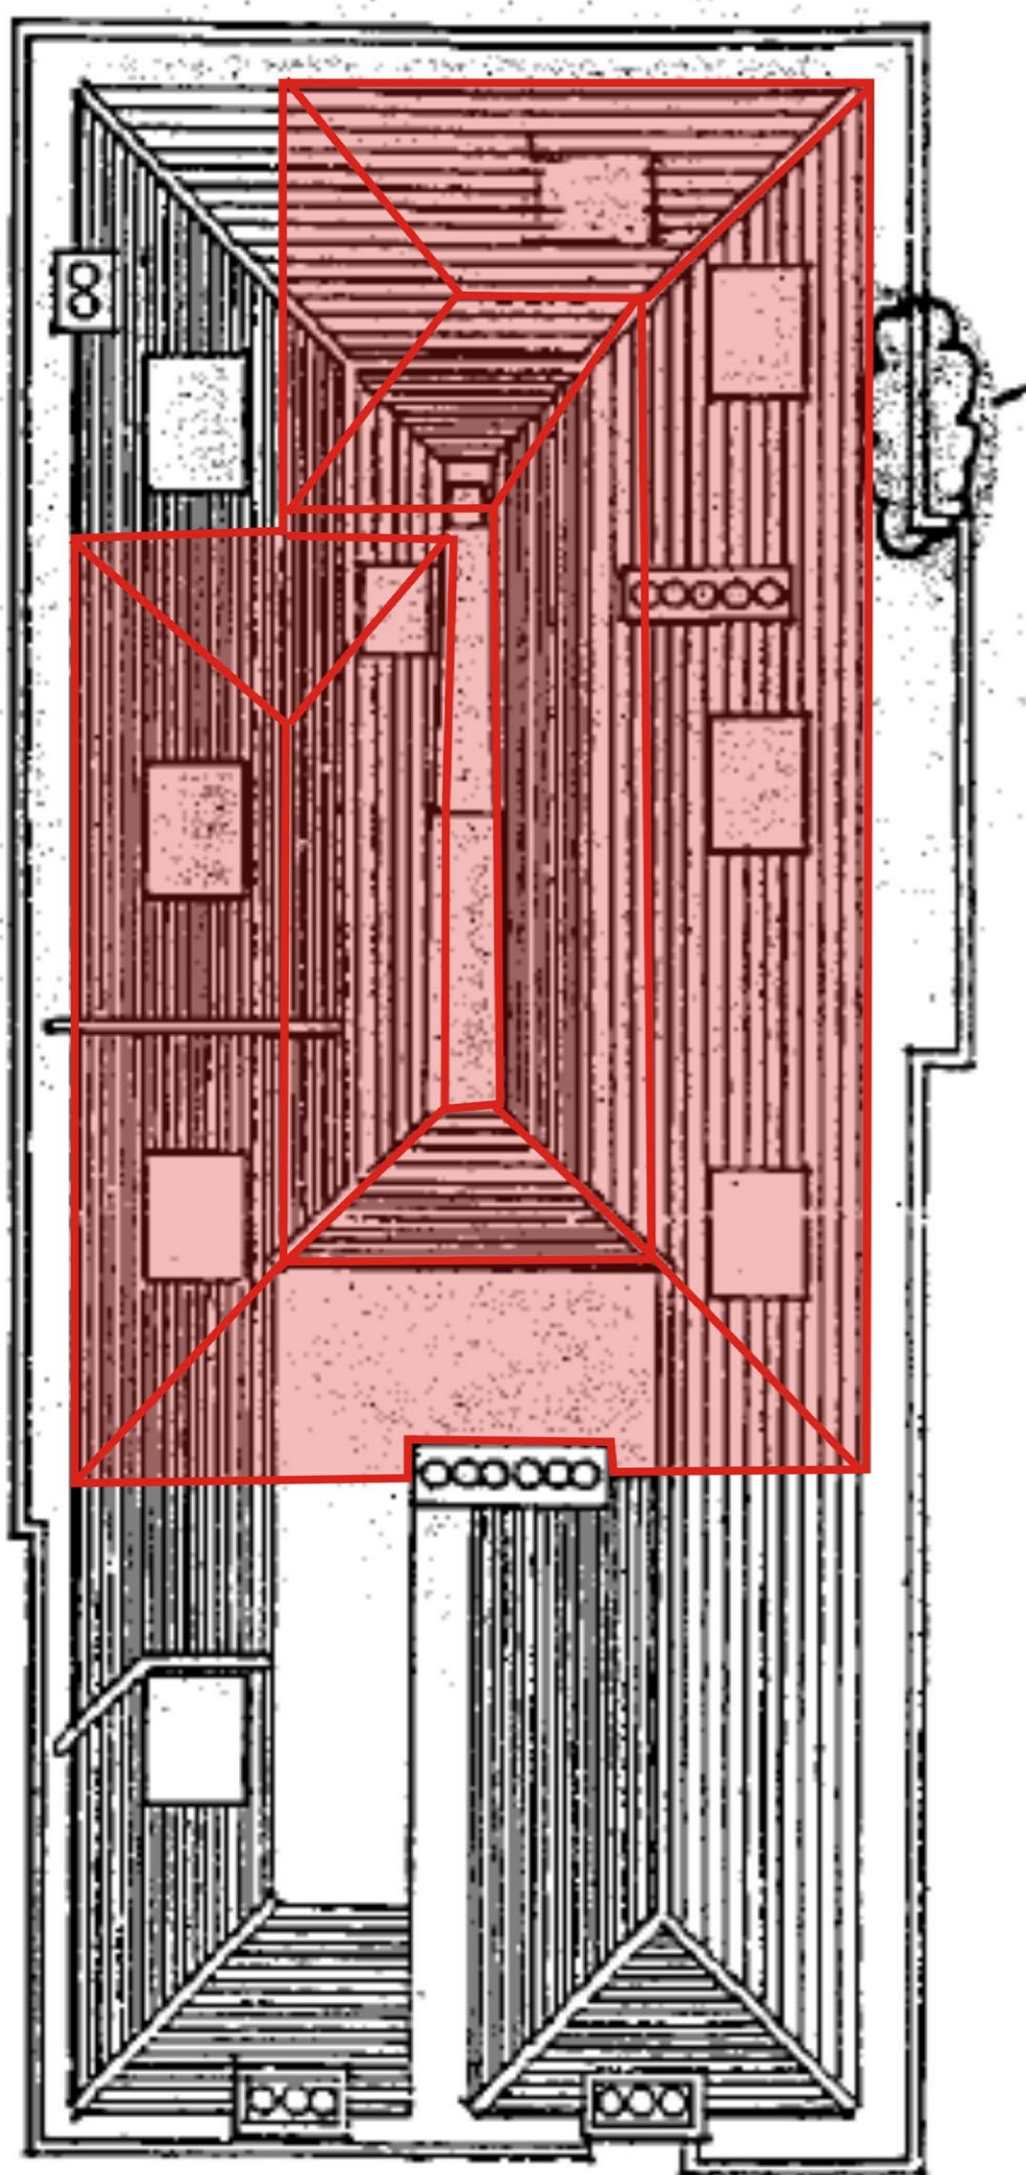
Canons - roof analysis. 'Analysis of Canons roof with original roof outlined in red'

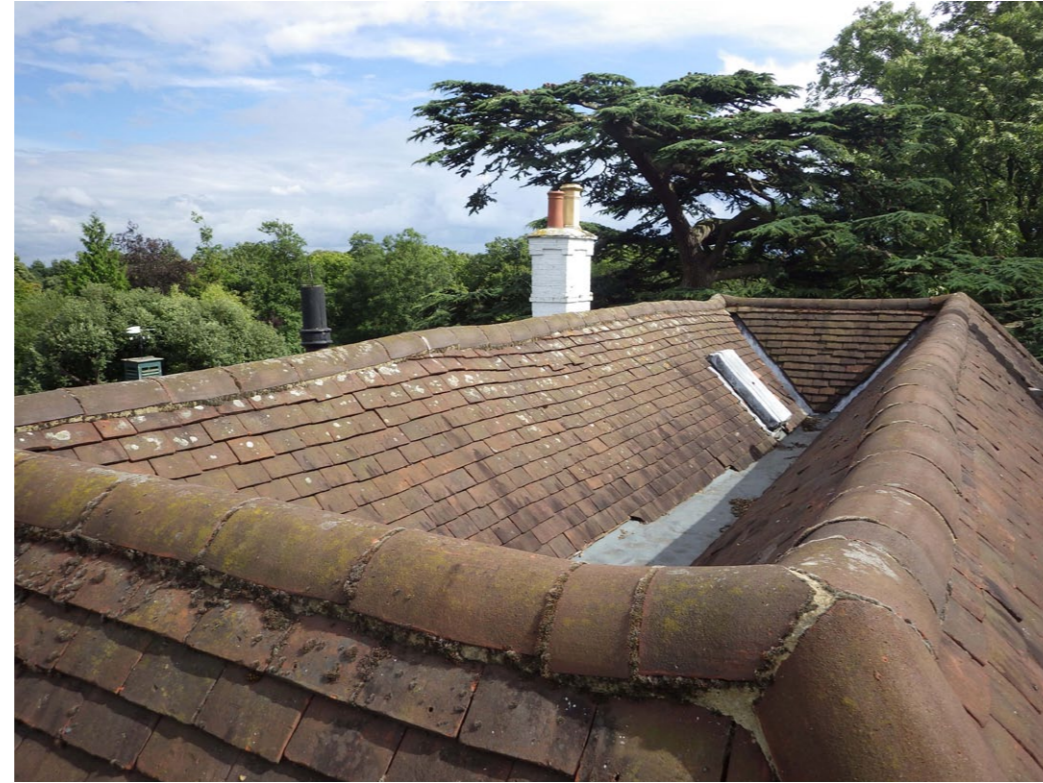
The roof valley, looking south

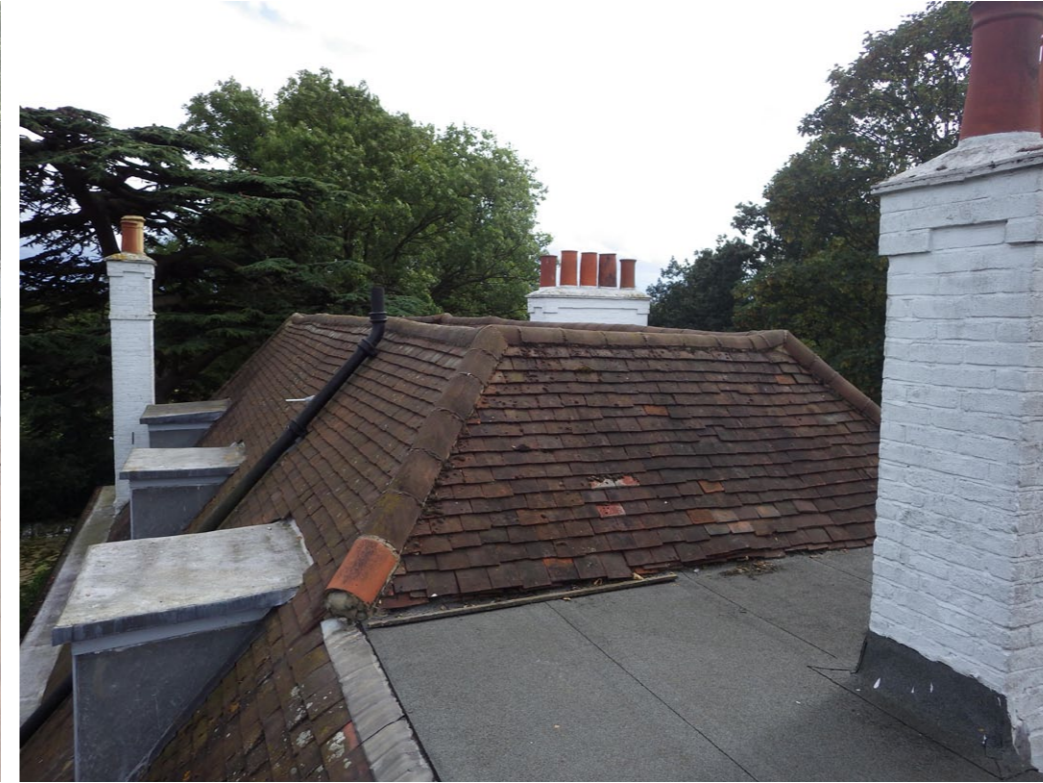
General view of the roof, looking south

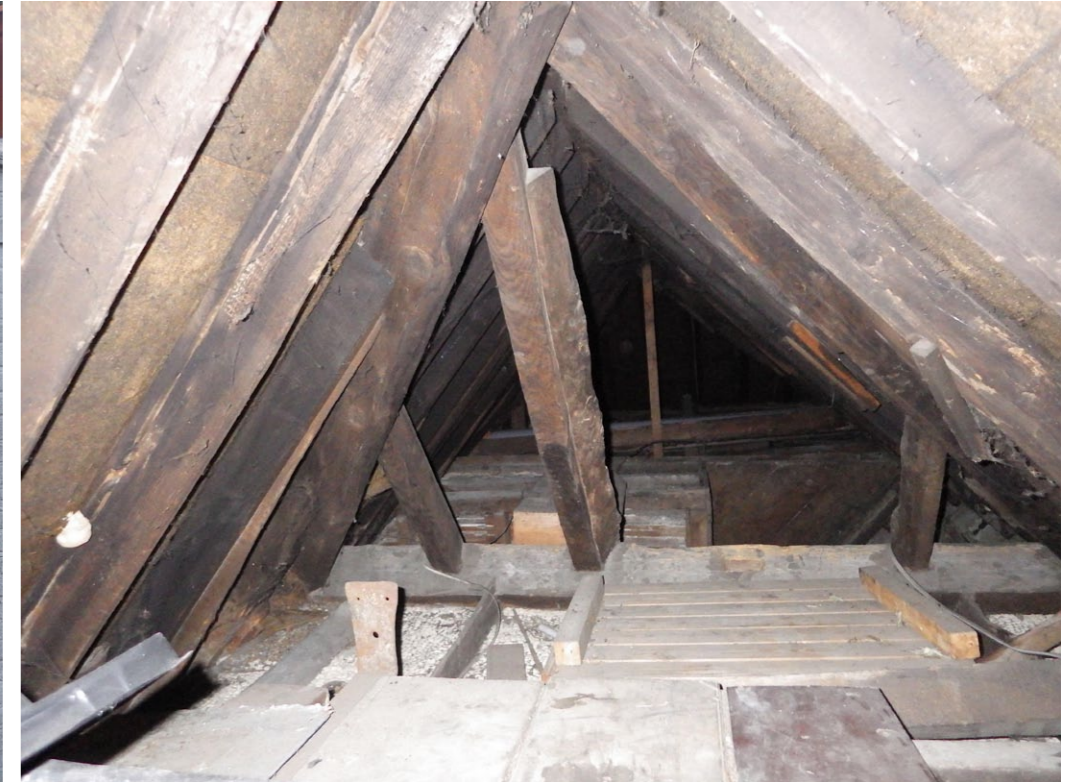
Inside the crawl-space of the roof structure, showing evidence of an earlier roof-pitch

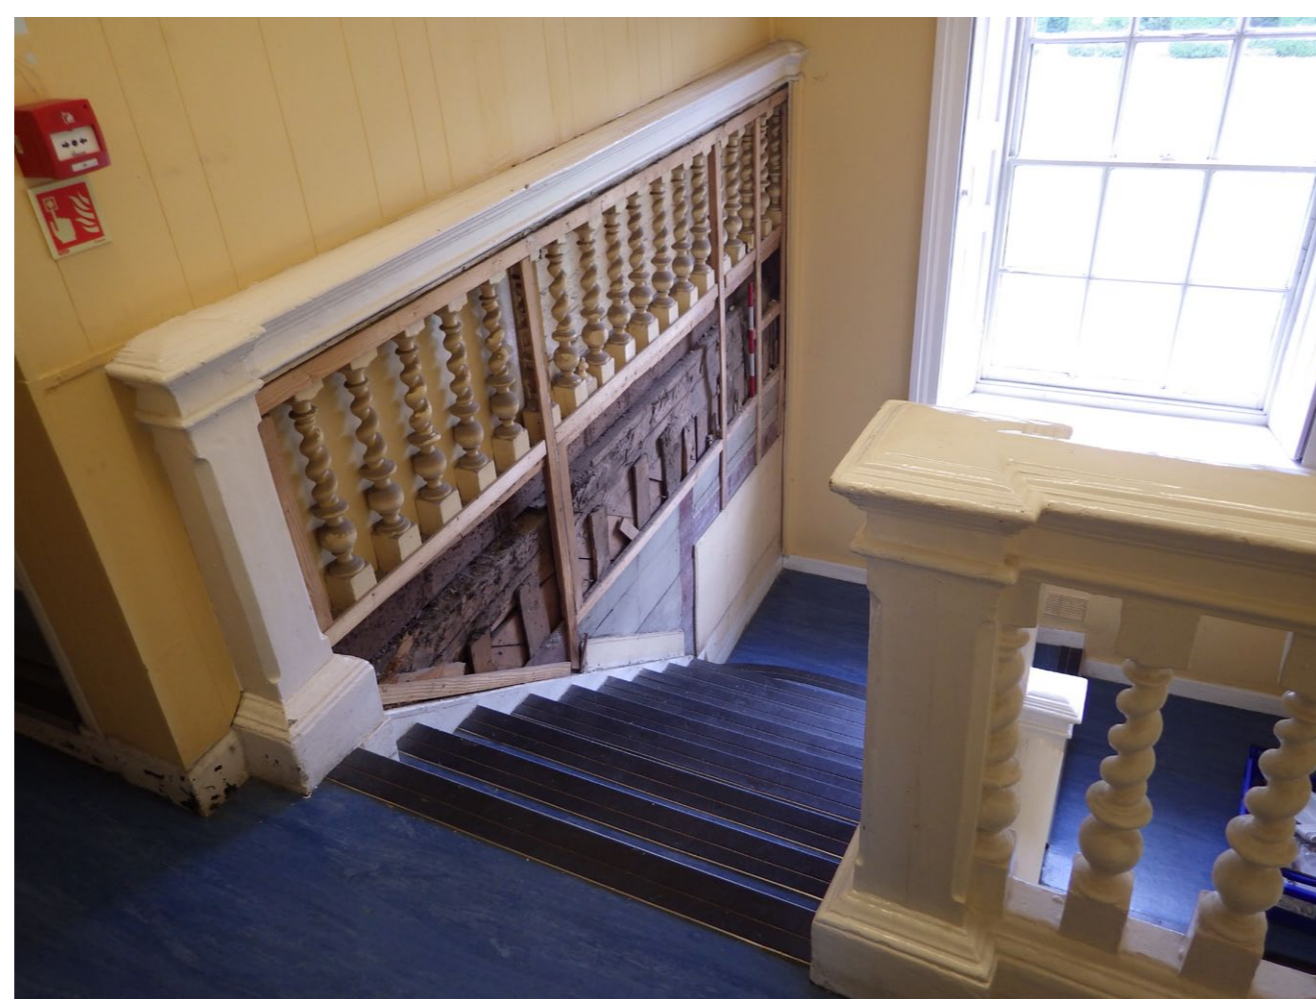
The boarding was taken off the stairwell wall above the upper flight on the north side. This revealed that the stair is in its original position. The stair wall is also confirmed as mostly original above the flight – the balustrade backed against panellled walling that boxed in a loft stair. The main stair is now confirmed as largely intact and is an excellent example of its type. It is suggested that the significance of this chamber be upgraded to 'considerable'.

Stairwell with panelling removed

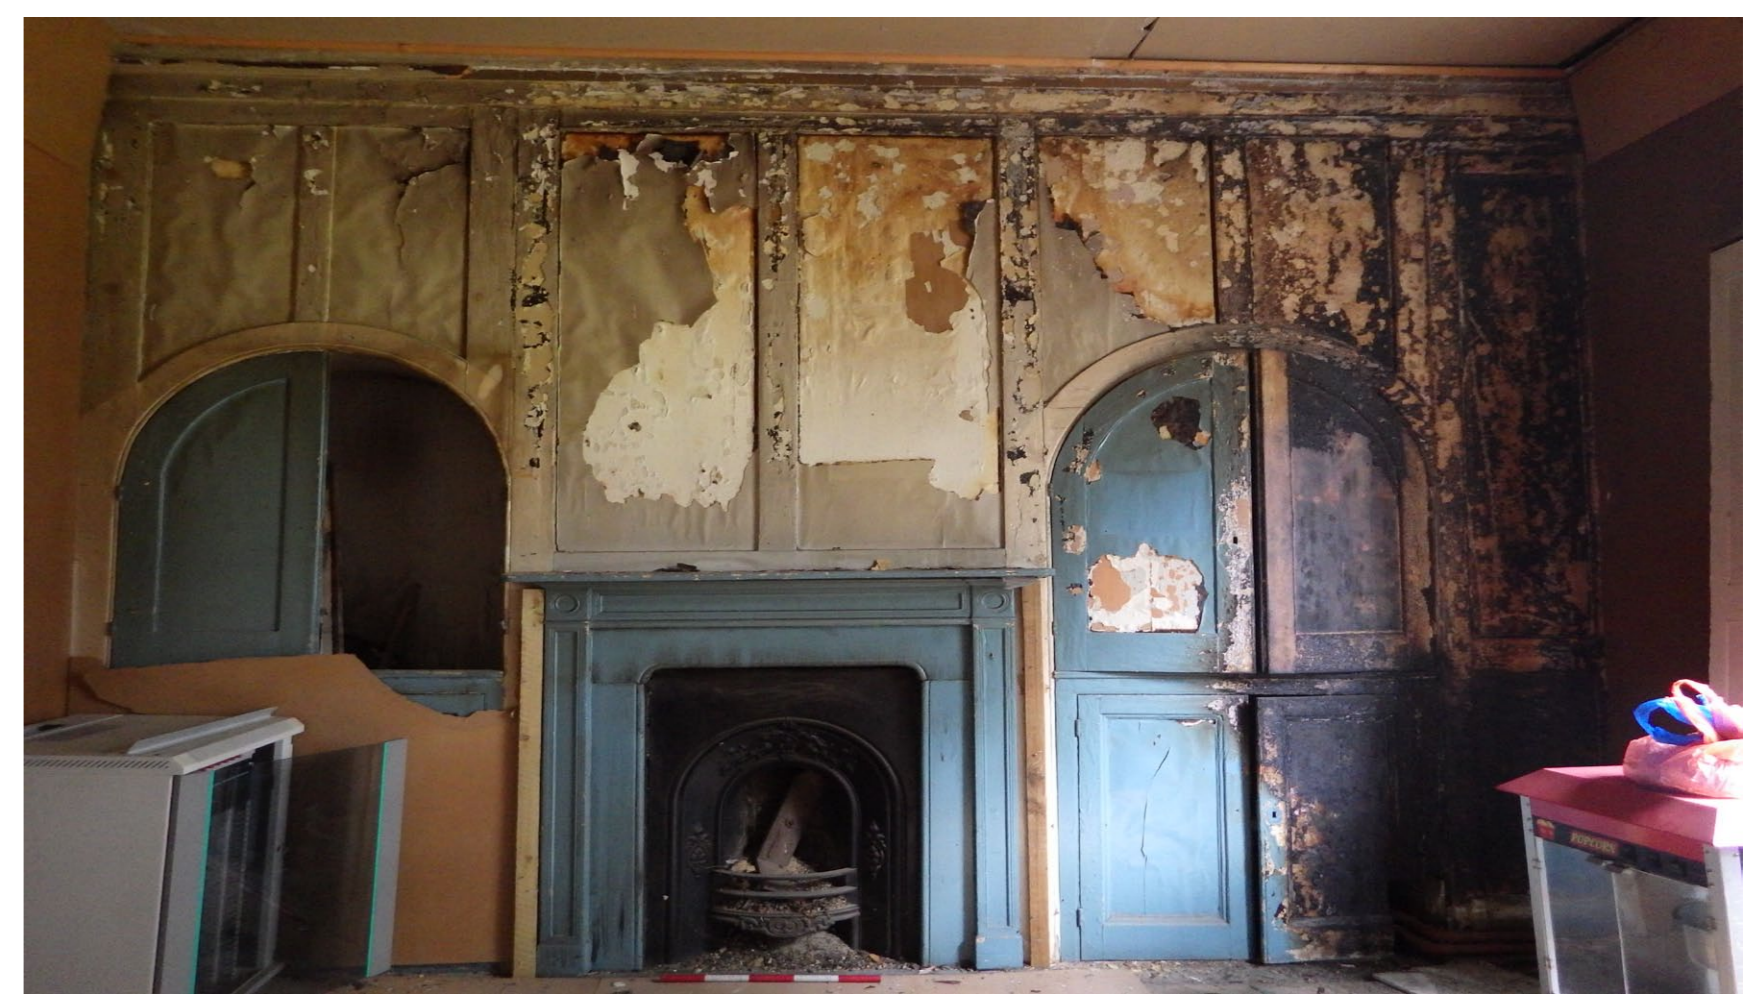
Fire-scorched panelling and fireplace exposed beneath hardboard lining'

This room was made accessible during the works. This room had been wholly lined out internally with thin hardboard. This boarding was stripped from the south wall and revealed fire-scorched but an otherwise wholly intact scheme of panelling, a fireplace and two presses. Panelling is expected to survive elsewhere beneath the hardboard within this interior. It is suggested that significance should be 'considerable'.

The room at the top of the stairs had been badly damaged by a fire, an arson attack that started at the main entrance on the floor below. Following the fire the interior of the roomed was lined out with boarding. Removal of the boarding during investigations revealed that the room had been fully timber-panelled and that the panelling, though fire-damaged, the timberwork remained almost completely intact.

On the south wall was revealed a well preserved early fireplace and arched two wall-presses (cupboards) with all their ironwork, shelving, etc. remaining. The fire had blistered the paintwork to reveal earlier decorative schemes below the upper layers, including a layer of patterned wall paper.

Because of the extent of survival and the quality of the earlier interior details the room was re-categorised at of considerable architectural significance. It is hoped that this interior can be reinstated to its former grandeur. This will require further investigation of the decorative paint finishes and some reconstruction of missing elements such as the cornice.
