**ARCHITECTURAL HISTORIC PAINT RESEARCH AND ANALYSIS**

**THE CANON'S HOUSE MITCHAM**

**REPORT DATE: MARCH 2019**

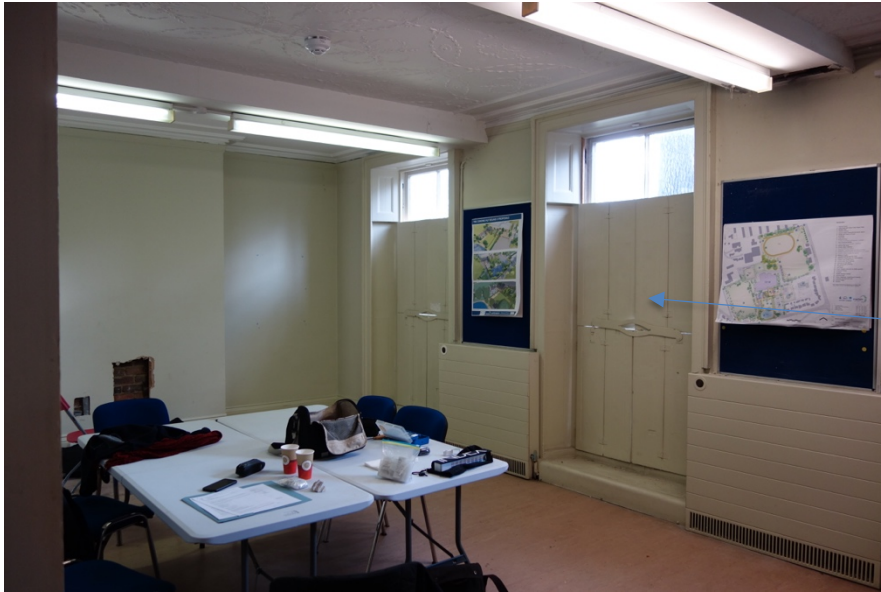
Figure 4: G02 Drawing Room

Within this interior the earliest schemes are found on the skirting and shutters, which appear to date from the second phase of alterations in the mid 18<sup>th</sup> century.

It has been possible to approximately date many of the layers from pigment content and paint type/colours. Scheme two is a typical eighteenth-century warm grey. Also, the eighteenth-century schemes are neatly capped by scheme nine, which has to date from after 1826, as the French ultramarine pigment only became available after that date. A popular C19<sup>th</sup> pigment, particularly in distempers.

The earliest evidence in G02 the Drawing Room was found on the door and consisted of lead white oil paint. Over this an eighteenth century 'Mahogany Colour' was applied for scheme two. This has a distinctive warm grey undercoat beneath it, which was also used as the finish coat for the shutters and skirting. The second scheme of a warm grey

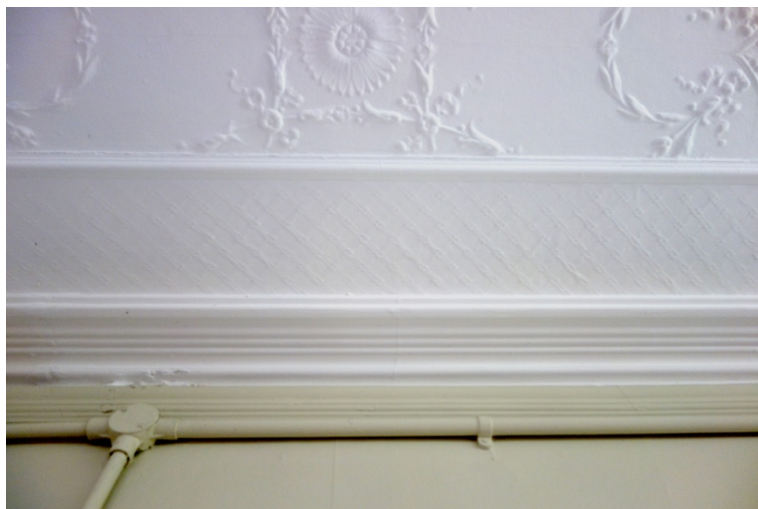
**Figure 8: Detail of ceiling cornice**

No evidence was found on the ceiling and cornice prior to scheme 9, which as discussed dates it to after 1826.

In addition, the embossed pressed ceiling paper, possibly an Anaglypta, Tynecastle or similar type, dates from the very late 19<sup>th</sup> or possibly 20<sup>th</sup> century. It is very much in the 'Adam revival' style, popular from the 1890s to the 1920s.

It is therefore entirely possible that all previous schemes applied to the cornice were in soft distemper and these were thoroughly washed off prior to any redecoration, and certainly before the scheme of pale blue lead oil paint was applied. There are small traces of a distemper like material beneath the blue lead paint, which possibly confirms this.

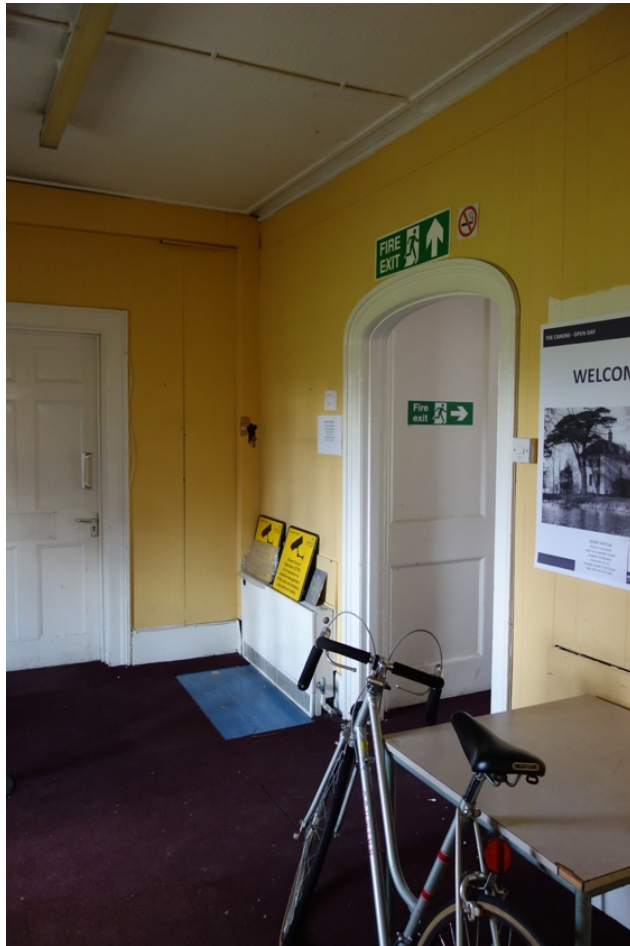
Figure 11: G01 Entrance Hall

The skirting within the Entrance Hall retains a complete decorative history and ties into the eighteenth-century finishes found in G02 the Drawing Room.

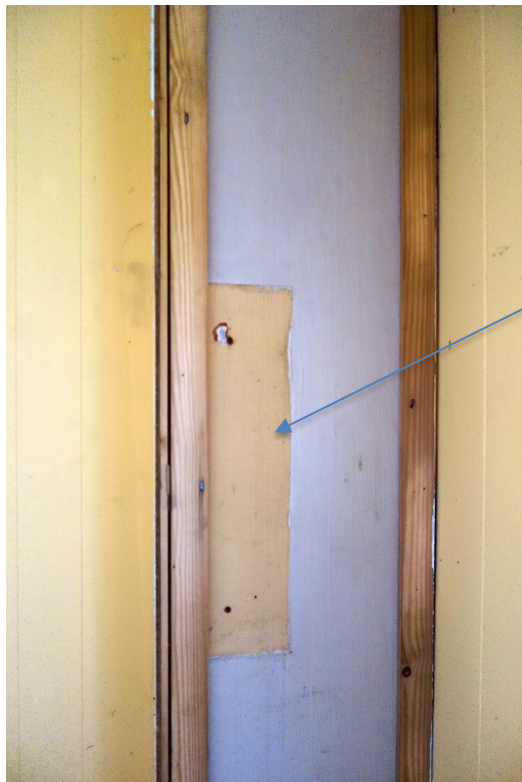
**Figure 13: Entrance Hall wall face**

The wall face sampling was restricted due to the extensive use of 20<sup>th</sup> century pine cladding, however an area of plaster wall face was identified to the left side of the main entrance door

The earliest evidence on the walls is a pale cream lead oil paint that occurs as scheme number 5 on the skirting sample. This provides a date of later nineteenth century for this finish. Overlying this the thick lining paper and orange/red scheme applied to it could be

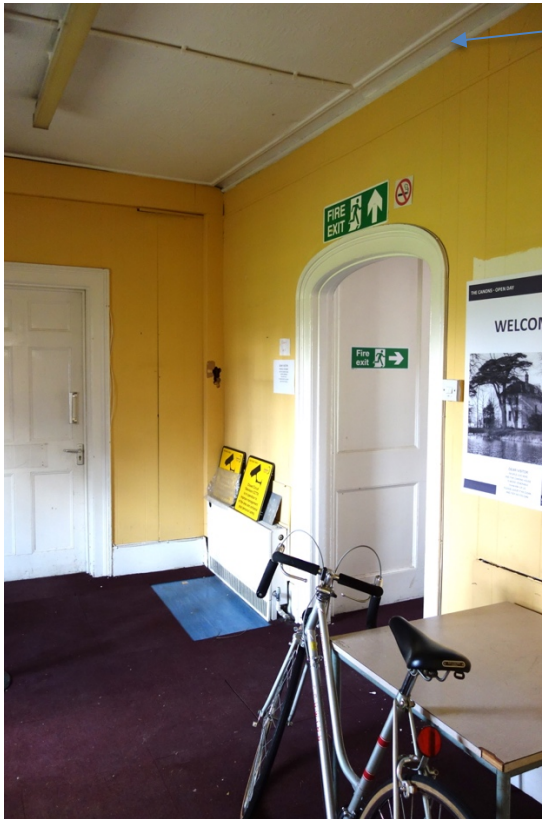
Figure 15: G01 Entrance Hall

In contrast to the wall faces the cornice, retains a very complete decorative history, including an original and early phase of soft distemper paints. Usually, these would be washed off prior to redecoration but not always, and their survival here is a strong indicator that distempers would have been used in other areas, where perhaps the information has been lost. For example, the adjacent G02 the Drawing Room

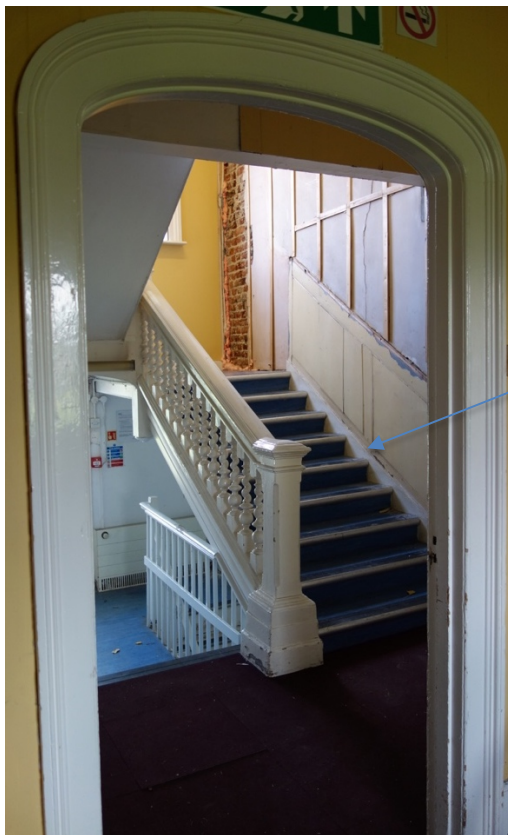
Figure 17: G03 Stair Hall & stairs

The Stair Hall and Stair has perhaps proved the most complicated area to disentangle due to the development and alterations over time. For a clearer explanation of the development please refer to the scheme chart provided for these areas prior to the summary for the space.

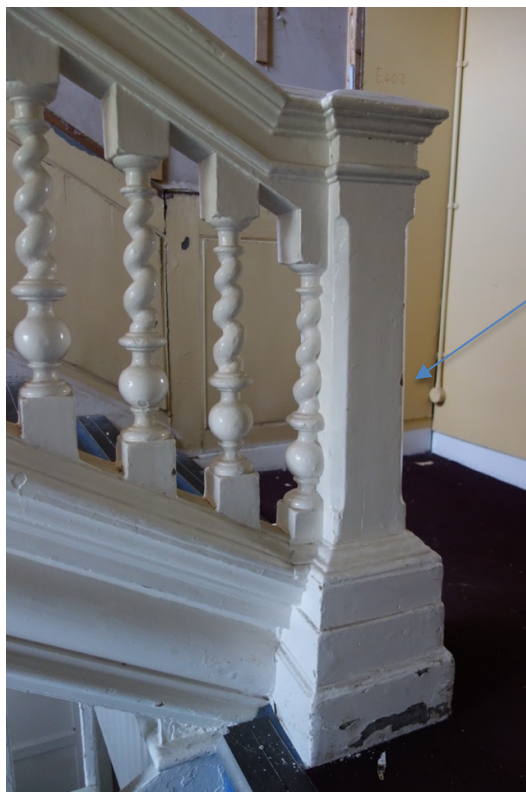
**Figure 21: Stair balusters**

The photomicrograph clearly shows 4 decorative phases of the stairs, the first strong mid creams of the late 17<sup>th</sup> century, when it was common to use darker muted tones, and the second the very distinctive grey colours extensively used during the Palladian period (see figure 20), then moving into the pale grey/creams. The third phase is the woodgraining period starting c1815 and continuing through the 19<sup>th</sup> century and finally the fourth phase of zinc-based paints using a white zinc varnish, used 1920's through to the 1950's. following on into the alkyd schemes of post 1950.

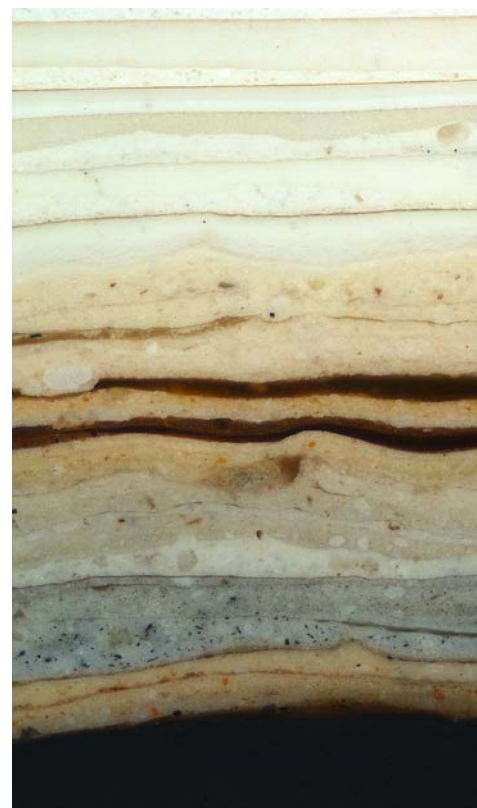
**Figure 22: Sample: TheCanons/ 4.6 Stair Newel**

- Schemes 18-20 of cream lead & alkyd oilpaints (not shown on this cross-section)
- Scheme 13-17 Pale cream & off-white zinc based oilpaint
- Schemes 11-12 lead white oilpaints
- Schemes 8-9 Mid oak woodgraining (3 schemes of woodgraining were found on the remaining joinery) Regency style
- Schemes 5-7 Pale grey/cream lead oilpaints
- Schemes 2-4 Pale grey lead oilpaints (early to mid 18<sup>th</sup> century)
- Scheme 1 Strong mid cream lead oilpaint (1680)
- Substrate softwood (not shown)

The strength of the late seventeenth century schemes and the drastic change to early eighteenth-century greys is particularly noticeable.

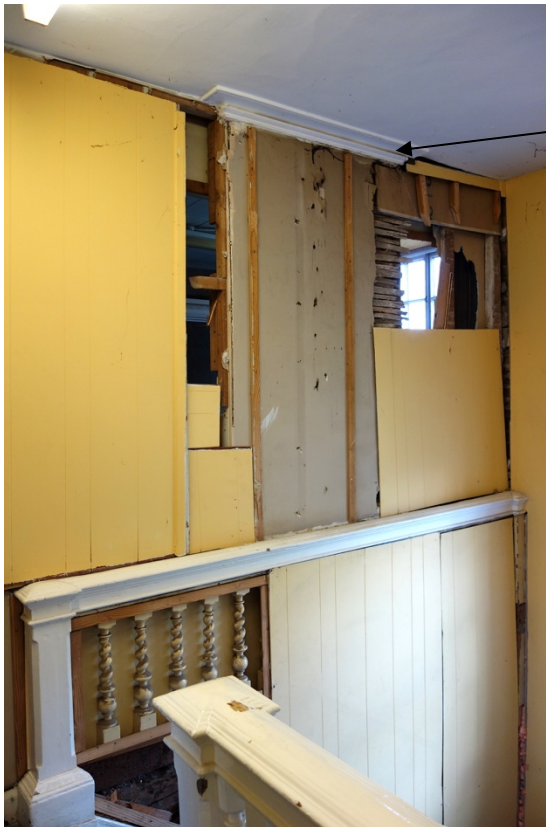
**Figure 23: First floor landing**

The schemes surviving on the cornice to the stair are again very similar to those found on the cornice within the Entrance Hall, following the same colour changes.

At some point in the early nineteenth century alterations and/or repairs were made to this area of the House. This included the door to F03 and the stair window on the half-landing. Woodgraining, particularly in imitation of pale and mid oak became very popular as early as 1812\* and continued throughout the 19<sup>th</sup> century. However, in this context a date of post 1815 would be more realistic.

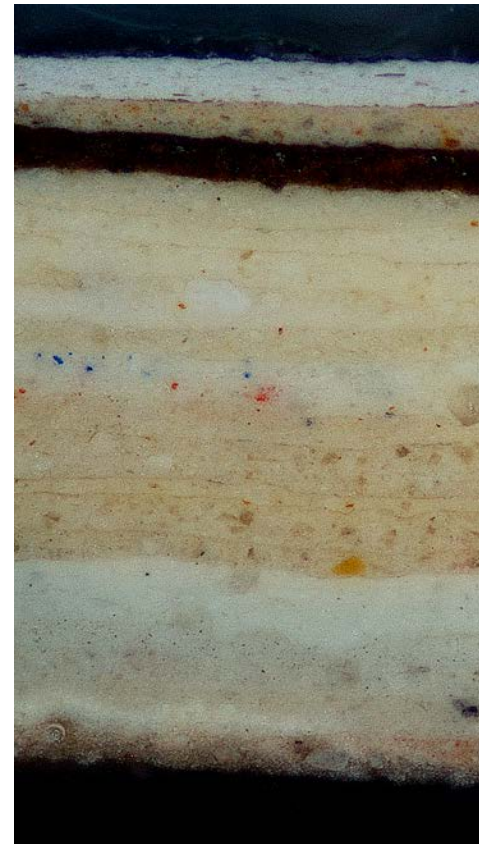
Figure 29: Sample: TheCanons/ 7.3 cupboard interior

*All in traditional lead oil paints*

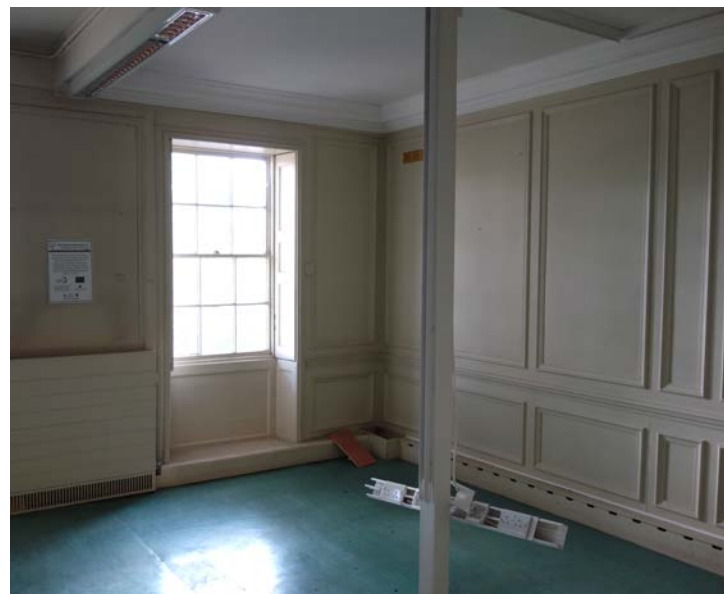
Figure 30: Room F02

Although not included within the original brief for the research, observations within this interior identified good survival of historic finishes. Now one large space, created from two separate interiors at some point.
