**Bat inspections, tree and  
buildings surveys and  
assessments and  
ecological review**

Site	The Canons, Mitcham
Project number	73218
Client name / Address	Alison Plant, The Canons HLF project, Merton Civic Centre, SM4 5DX

Date of issue	11/09/18
Version number	D002
Revisions

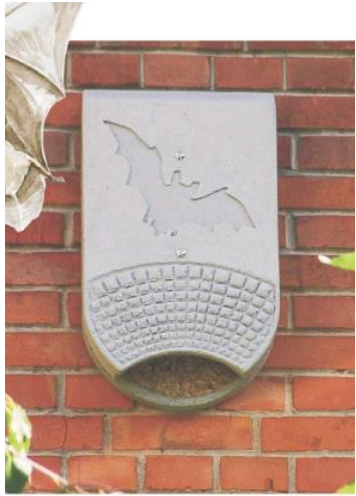
Example	Description	Picture
Schwegler 1FQ	<p><a href="http://www.schwegler-nature.com">www.schwegler-nature.com</a></p> <p>Dimensions: 60(h) x 35(w) x 9(d) cm Weight: 15.8kg Installation: Attached to most external brick, timber or concrete walls at least 3m high. Can also be placed inside roof space</p> <p>This box is ideal for all types of bats that inhabit buildings. The box is weather-resistant and is also temperature controlled and self-cleaning. The front panel of the box can also be painted during manufacture, to match an existing colour.</p>

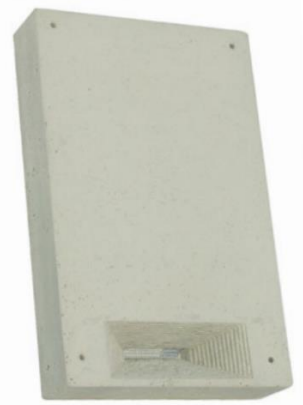
Schwegler 1WI	<p><a href="http://www.schwegler-nature.com">www.schwegler-nature.com</a></p> <p>Dimensions: 55(h) x 35(w) x 9.5(d) cm</p> <p>Weight: 15kg</p> <p>Installation: Attached to most types of external brick, timber or concrete walls. It can be installed flush-mounted and rendered over or simply against the wall. It should be installed at a height of at least 3m.</p> <p>This box typically attracts building-inhabiting bat species like Pipistrelle or Serotine Bat.</p> <p>This box is weather-resistant and designed for both winter hibernation and larger colonies in summer, including nursery roosts.</p>

<p>The image shows a single Schwegler 1WI bat box. It is a light-colored, rectangular box with a slightly protruding front panel. At the bottom of the front panel, there is a small, rectangular entrance with a fine mesh screen. The box is shown against a plain white background.</p>

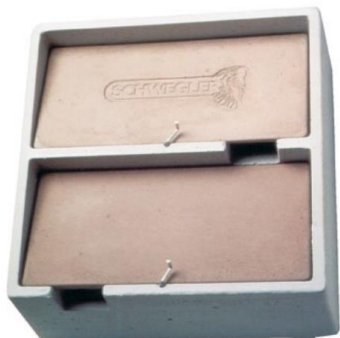
Example	Description	Picture
Schwegler 1MF (Swift and Bat)	<p><a href="http://www.schwegler-nature.com">www.schwegler-nature.com</a></p> <p>Dimensions: 46(h) x 43(w) x 22.5(d) cm. Weight: approx. 24 kg</p> <p>Installation: The box can be hung against any types of wall of any type of building, between 6-7m above ground level.</p> <p>This box is designed for nesting swifts, however the recess in the rear panel creates a space between the wall of the building and the box, making it ideal for bats that inhabit building, such as Common Pipistrelle. Whilst the box may require cleaning, the back recess for bats requires no maintenance.</p>

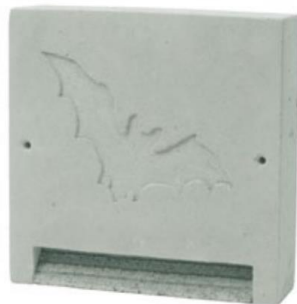
Schwegler 1FE	<p><a href="http://www.schwegler-nature.com">www.schwegler-nature.com</a></p> <p>Dimensions: 30(h) x 30(w) x 8(d) cm. Weight: approx. 5.1 kg.</p> <p>Installation: Installation of multiple units is recommended. The box can be integrated into insulation or masonry. It can also be attached to the underlying structure to cover existing cavities, allowing bats to still sue them. Install at least 3m above the ground.</p> <p>This is a general-purpose box, suitable for all species. There is a maintenance-free access panel for installing on or in the surface of exterior walls. The open rear enables bats to continue to use existing nesting sites in walls.</p>

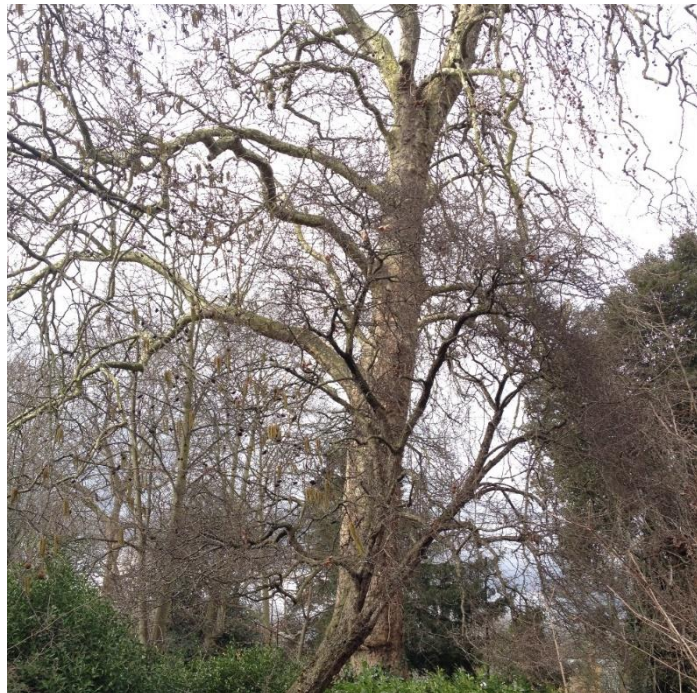
**Photograph 4: Tree 33**

33	<i>Salix babylonica</i> var. <i>P. Tortuo</i>	Low	Some hollow sections although access points are limited to a crack in exposed heartwood and sapwood at a previous cut. See Photograph 4 and Photograph 5.
38	<i>Malus floribunda</i>	Moderate	Crack leading to hollows at 1-3m on east aspect providing a moderate suitability roosting feature, inspected with endoscope and no bats present. Crack at 4m height with low suitability to support bat roosts. See Photograph 6.
45	<i>Cedrus atlantica</i> 'Glaucá'	Moderate	Knot hole with staining (and a snail's trail) below access point at 7m height on west aspect which may lead to a cavity, thus classed as moderate suitability roosting feature. No other significant roosting

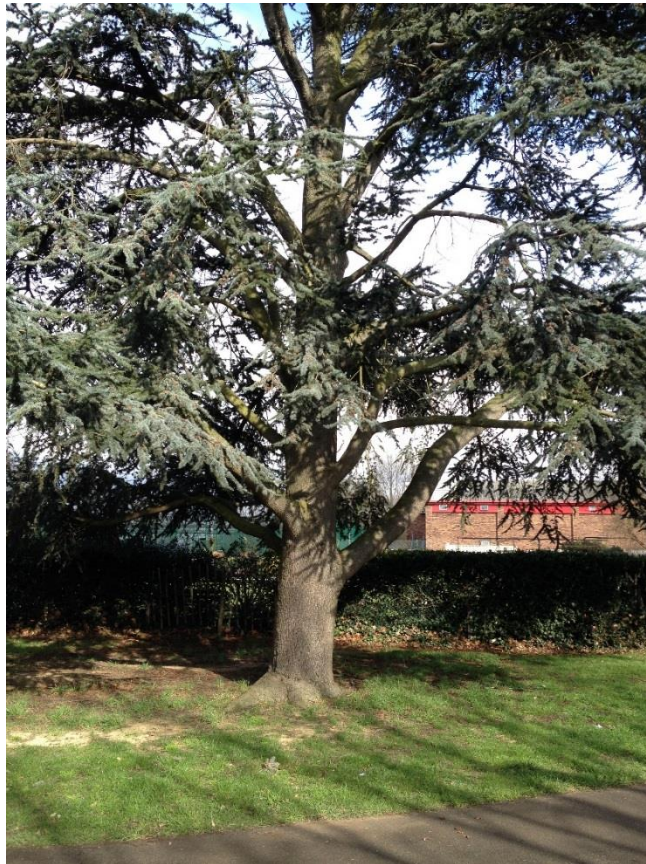
**Photograph 7: Tree 45**

Tree*	Species	Roost Suitability	Descriptions of potential/actual roost features
			features visible from ground level. See Photograph 7.
73	<i>Prunus avium</i>	Low	Some knot holes with cracks and generally in poor condition, although these features would be unsuitable to support multiple bats.
95	<i>Aesculus hippocastanum</i>	Moderate	Hole in branch at 5m height over path on east aspect. Mature tree and other roosting features may be present but none visible from ground level. See Photograph 8.
102	<i>Fraxinus excelsior</i>	Moderate	Large internal cavity, with lateral crack on stem at north aspect. See Photograph 9.
122	<i>Prunus avium</i>	Low	Some flaking bark and wounds at 4m height on west aspect leading to small cavity. Not suitable for roosts of higher conservation value.
126	<i>Fraxinus excelsior</i>	Moderate	Two large cavities on main trunk at 8m height on south aspect. Lower feature not very suitable however upper feature is of moderate roost suitability. See Photograph 10.

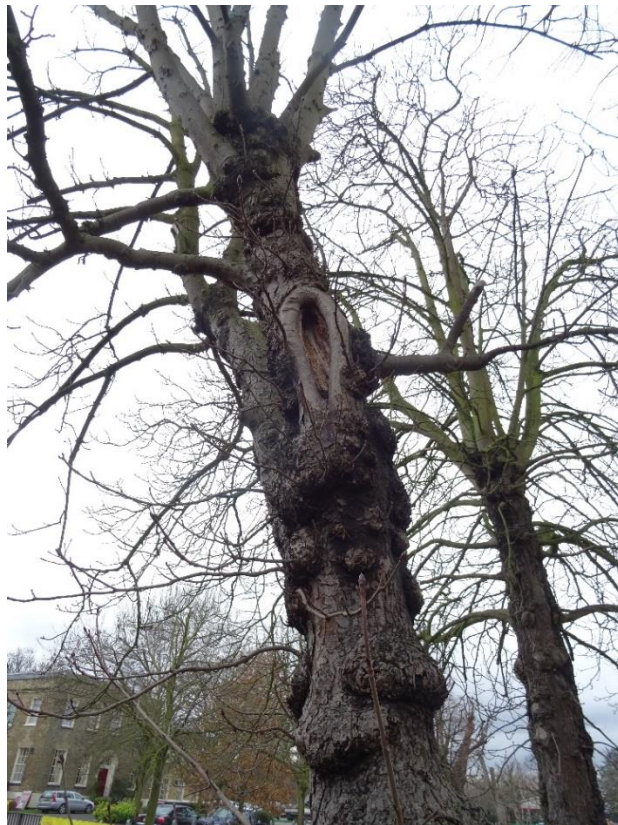
**Photograph 16: Tree 329**

328	<i>Tilia x europaea</i>	Low	Large tree, not possible to assess entire tree from ground level.
329	<i>Aesculus hippocastanum</i>	Moderate	Large cavity at 2.5m height on east aspect. Inspected with endoscope and contained no bats, but has moderate roosting suitability. See Photograph 16.
331	<i>Tilia x europaea</i>	Low	Large tree, not possible to assess entire tree from ground level. No clear bat roosting features.
332	<i>Tilia x europaea</i>	Moderate	Three small holes and knot holes at 7m height on west aspect, which provide some suitable roosting locations. See Photograph 17.
335	<i>Tilia x europaea</i>	Moderate	Some knot holes and cavities at 8m height on south aspect. See Photograph 18.

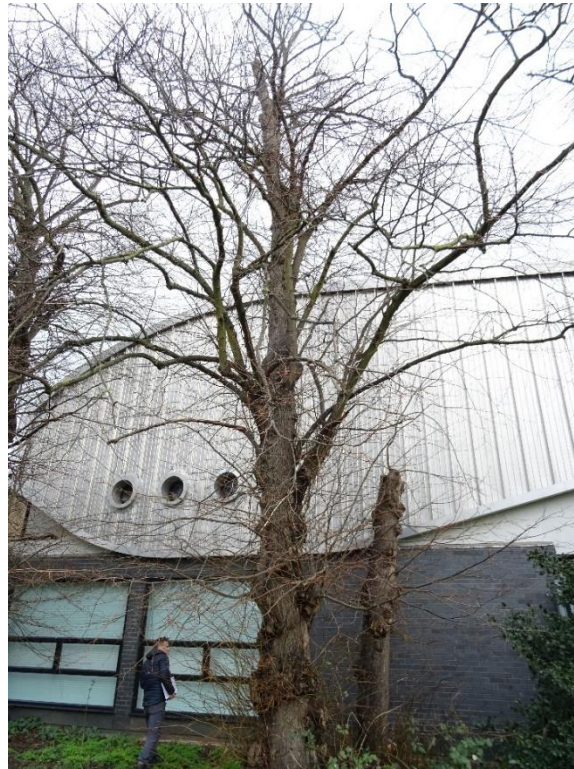
**Photograph 19: Tree 337**

Tree*	Species	Roost Suitability	Descriptions of potential/actual roost features
336	<i>Tilia x europaea</i>	Low	Some cavities at 2-3m height but of low suitability as quite enclosed.
337	<i>Tilia x europaea</i>	Moderate	Deadwood at top of main stem and hole on west of main stem at 10m height. See Photograph 19.
338	<i>Tilia x europaea</i>	Low	Two holes at 10m height on west aspect, of low roosting suitability.
349	<i>Fraxinus excelsior</i>	Low	Some cavities present for which access points are upward facing and thus likely to collect water.
355	<i>Quercus robur</i>	Moderate	Lateral crack at 4m height on south. See Photograph 20.
356	<i>Quercus robur</i>	Moderate	Several areas where cut branches at 6m and 8m height, provide small holes which may lead to larger cavity. See Photograph 21.
357	<i>Quercus robur</i>	Moderate	A snapped area has formed a cavity at 10m height on east aspect of main stem. Knot holes at 8m height on west. See Photograph 22.

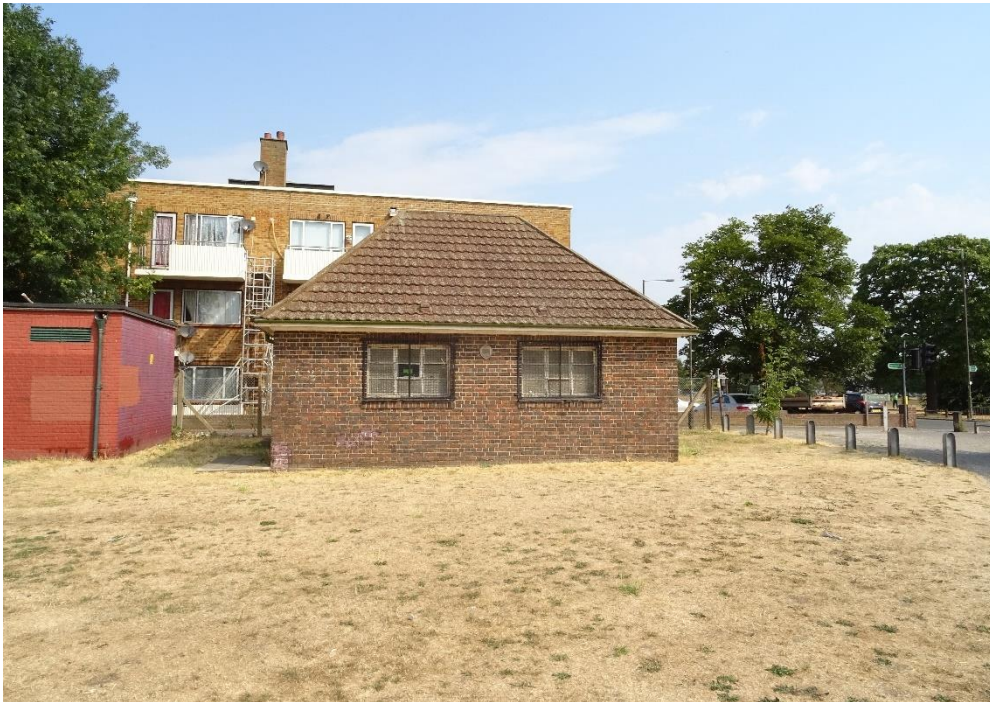
**Photograph 23: Changing block southern aspect**

Building	Roost suitability	Description	Bat roost evidence and potential
Changing Block	Low	A brick-built structure with solid walls (See <a href="#">Appendix 4</a> , Photograph 23). The building has hipped ends with no cladding or hanging tiles present. The roof is covered with tiles and was in a good condition, with interlocking tiles well sealed. The inside of the building was inaccessible.	A number of gaps under the roof ridge and tiles. On the western aspect of the building this was more predominant. On the eastern aspect there were two large gaps under tiles (Photograph 24, Figure 7, Target note 3) and between the soffit box. On the south-west corner there was a large hole under a tile (Figure 7, Target note 4). This would offer some access for bats but no direct evidence of roosting bats was observed. The surrounding area was poor for foraging or commuting bats with a busy road to the east and a residential area to the north and immediately adjacent.

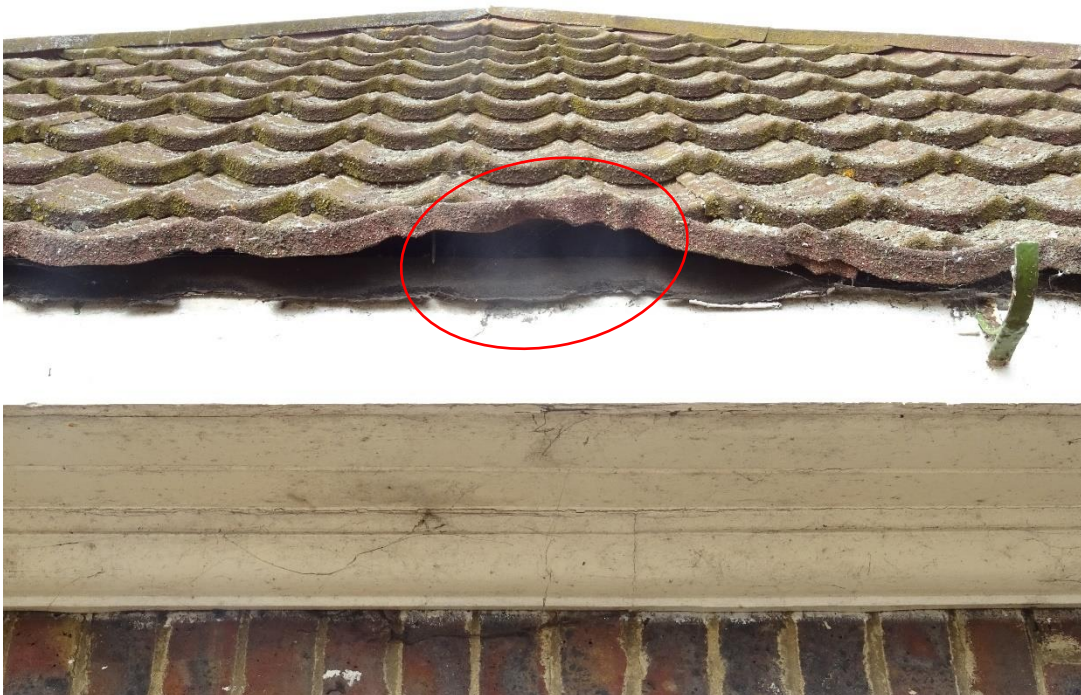
**Photograph 24: Gap under roof tiling of Changing Block (eastern aspect)**

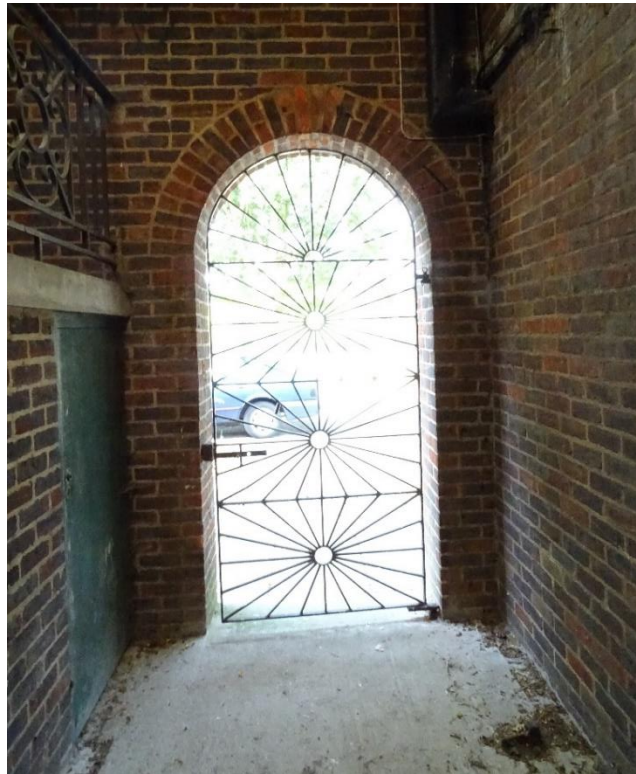
**Photograph 25: Metal grille door at Toilet Block**

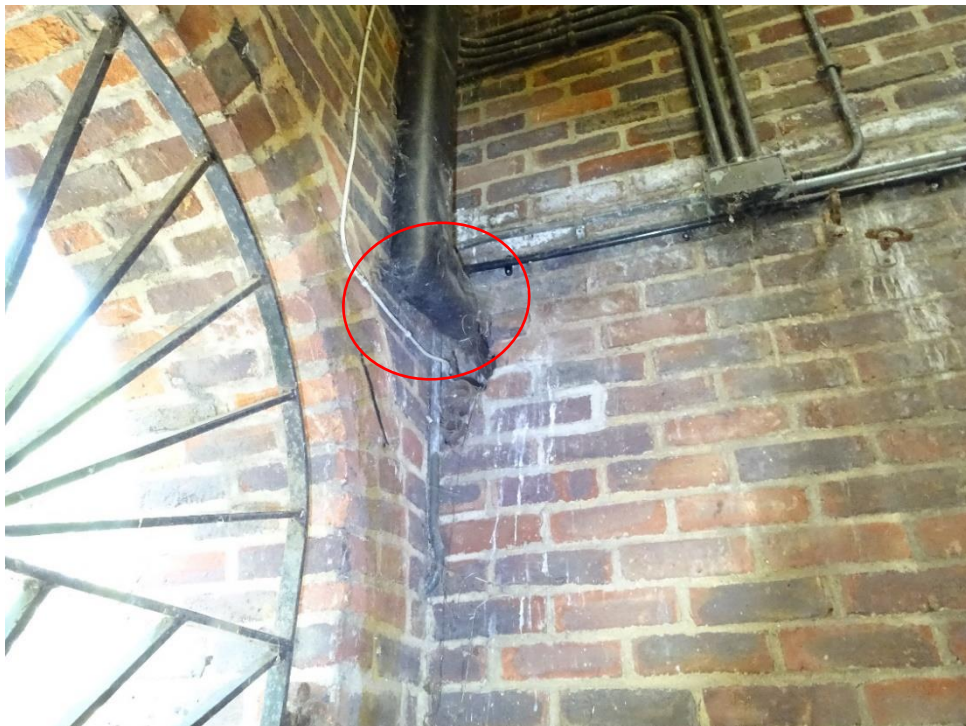
**Photograph 26: Large hole in Toilet Block entrance**

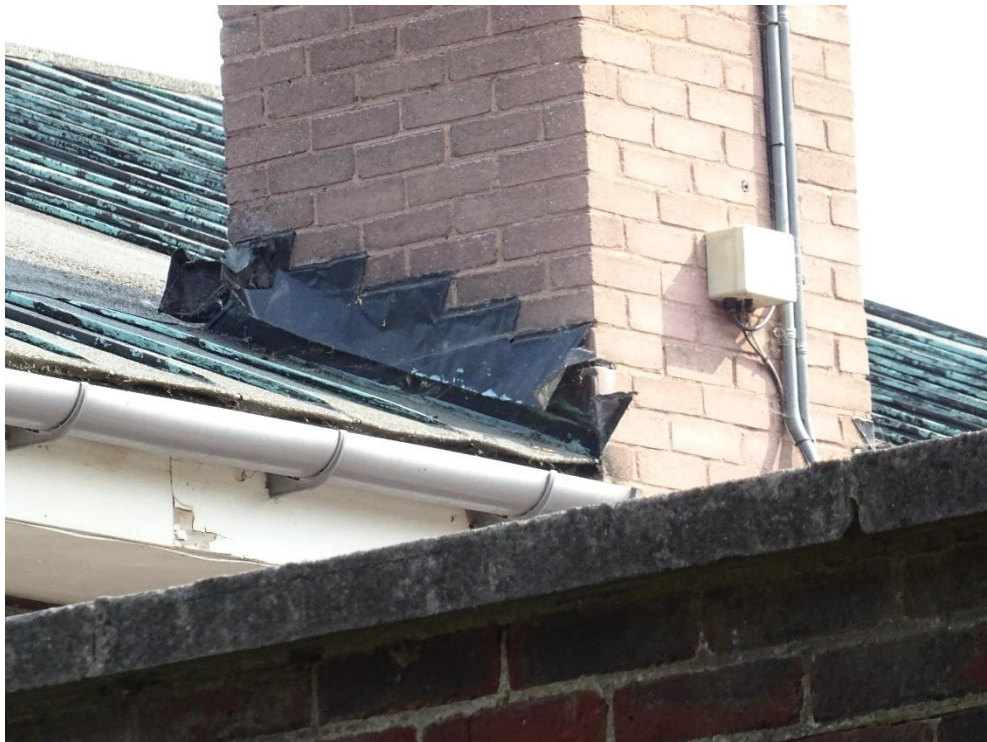
Building	Roost suitability	Description	Bat roost evidence and potential
		appears to be in a good condition. There is no roof lining or insulation.	(droppings etc) was found within the building.
Madeira Hall	Moderate	A brick-built sports centre with a cavity wall (Photograph 27). The roof was metallic with gable ends. The eaves were sealed by a soffit box and were securely held in place. Lead flashing was present around parts of the chimney. The building has a false ceiling which is well sealed within. Metal trusses hold up the roof and there is plyboard underneath the roof covering.	Although no direct evidence of roosting bats was found, there were a number of features that showed potential to support bat roosts. There were gaps present underneath the roof's ridge covering. On the eastern aspect, the gable ends of the soffit box were pulling away, creating a gap and a good roost feature (Target note 1, Figure 6). The eastern aspect of the building was in a much worse condition than the western aspect. On the southern aspect there was a crack underneath the barge boards, however, this was covered in cobwebs. The lead flashing around the southern chimney was in a poor condition, providing potential access points for bats (Photograph 28, Figure 6, Target note 2).

**Photograph 28: Lead flashing on southern aspect of Madeira Hall**

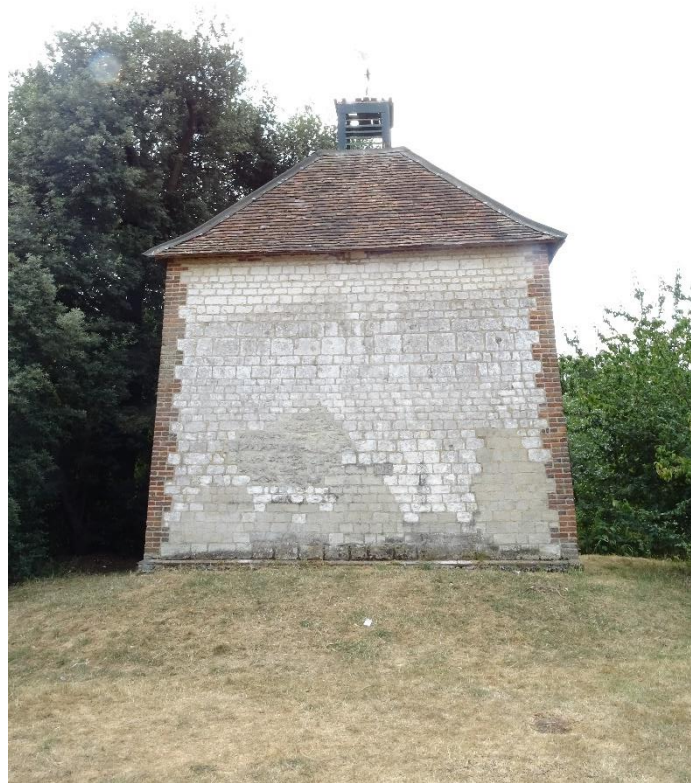
**Photograph 29: The Dovecote northern aspect**

The Dovecote	Moderate	A brick-built structure with a cavity wall and no cladding or hanging tiles (Photograph 29). The roof is tiled, with hipped ends. The eaves are open and there is no lead flashing. The roof has a bitumen layer and within the Dovecote there	No direct evidence of bats was found within this building. However, there were numerous access points for bats around the door frame (eastern aspect) and there is good available foraging habitat nearby. The open

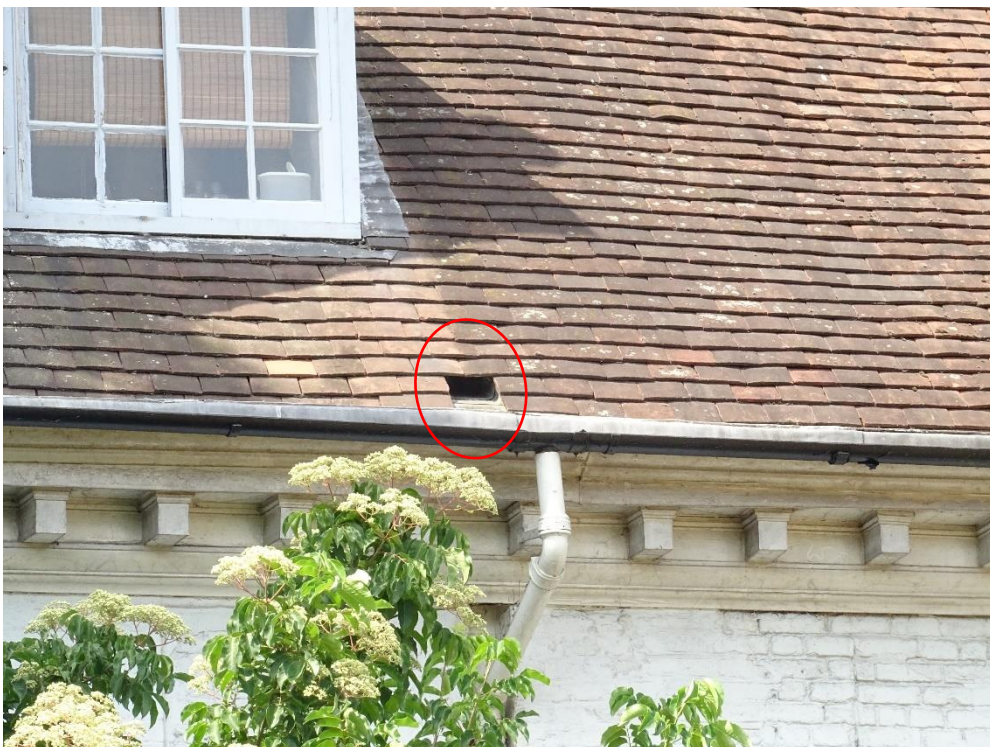
Building	Roost suitability	Description	Bat roost evidence and potential
			under the guttering, and there were no cobwebs (Figure 5, Target note 5). An entire tile was missing on the eastern aspect, creating a large gap (Photograph 34, Figure 5, Target note 9). In addition to these features, the building is in close proximity to a tree known to have a bat roost (south of building) (Figure 5, Target note 6) and the surrounding habitat is good for potential foraging and commuting bats.

**Photograph 34: The Canon's House missing roof tile (southern aspect)**
