# The Canons, Mitcham

Conservation plan - September 2016  
Final issue

Simpson & Brown

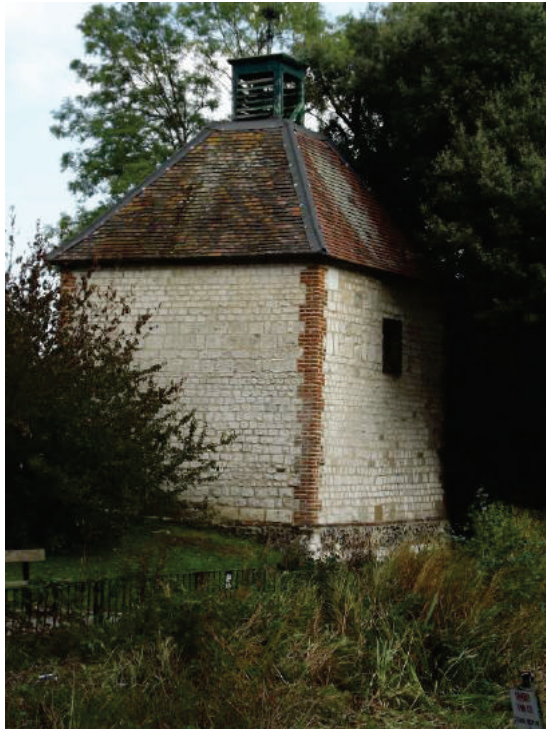
On the north side of the roof some repairs to the tiles are needed but not stripping and retiling. New lead flashings are needed to corners although it might be possible to fit ceramic copes to these ridges or to make mitred hips. There are some broken tiles next to the north-east hip.

**Figure 31** View looking north east towards dovecote.

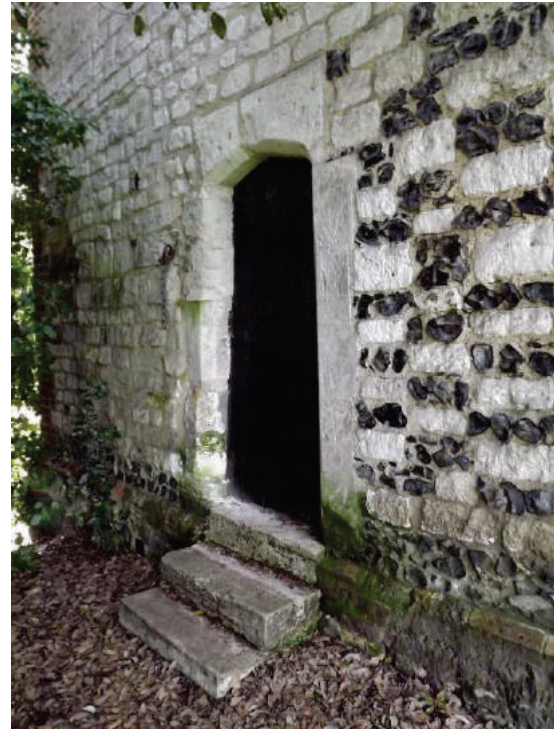
**Figure 32** View of east elevation entrance with flint knapping on right, looking south west.

On the east side there is a small area of flint knapping to the north of the door and also a flint course on both sides. The stone door surround has a Tudor or pseudo four-centred arched head. It could have been rescued from another building or it could be a survival from an earlier building. There is a change in the quality of the masonry both above the knapped area and above an area of quite squared stone. The roof is difficult to inspect on the east side due to the proximity of a tree.

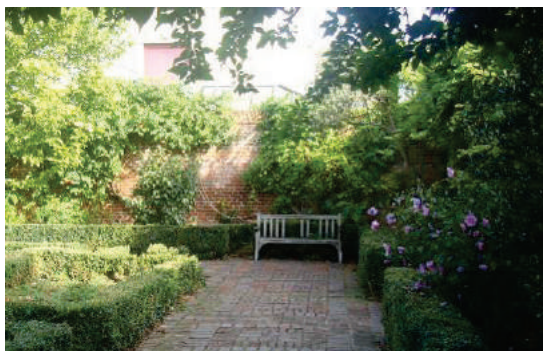
**Figure 37** View looking north in walled garden.

There is evidence of some alterations, possibly a door in the north-east corner. The brickwork walls are in fair condition. There is some pointing required to the upper courses of all of the walls. The brick on-edge copes should be lifted throughout, a damp proof membrane fitted and the brick copes rebbed on top of it. There is some evidence of structures, possibly greenhouses etc, built against the inner face of the west wall. This is suggested by the amount of paint on brickwork particularly in the joints. The walled garden has attractive, mid-20<sup>th</sup> century paving. The doors of the walled garden are modern but of good quality.

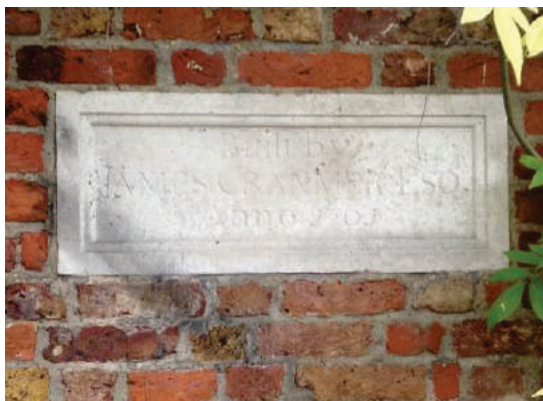
There is a panel built into the wall with the inscription, "Built by James Cranmer Esquire, anno 1761". An undated historic photo from the second half of the twentieth century shows that there was different brickwork surrounding the plaque, and shows that it has been entirely re-set.

**Figure 39** Limestone plaque of James Cranmer IInd, 1761, *ex situ* from other side of the wall.

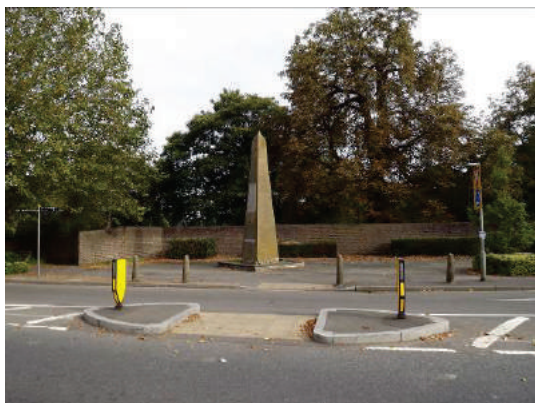
The base of the obelisk appears to be lower than originally intended with the lining out of the masonry not continued down to the ground and some rough patching which suggests that it was originally under the ground. It is surrounded by some quite poor looking granite wall about 300mm high.

**Figure 41** View looking east at obelisk.

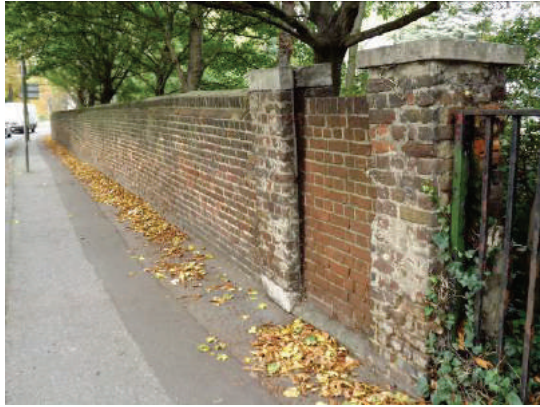
and about 2sqm of repointing. This gateway is likely that depicted in the 1823 watercolour (**Figure 7**). However, it is clear that the eastern pier has been moved, as the western pier is tied in to the adjacent wall and sits on a stone base. Archaeological investigation would determine its original position.

**Figure 44** South wall (east part) looking west showing pedestrian gate.

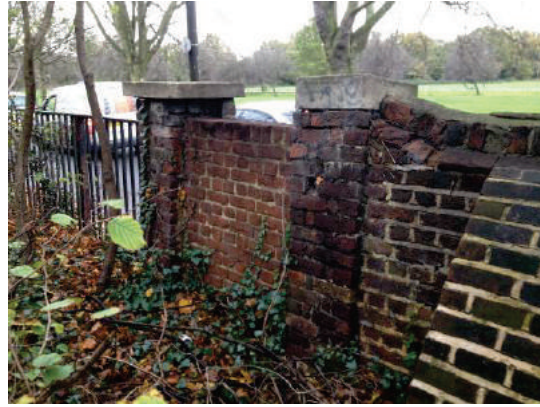
**Figure 45** View of same gate looking south, with buttress on right.

Further south there are other buttresses. These buttresses have a curving profile and appear all to have been built at a similar time. The wall is in generally good condition but does require repointing and some rebedding of copes. Possibly around 20sqm of repointing and about 5 linear metres of cope rebedding between the north end of the wall and the south gates.

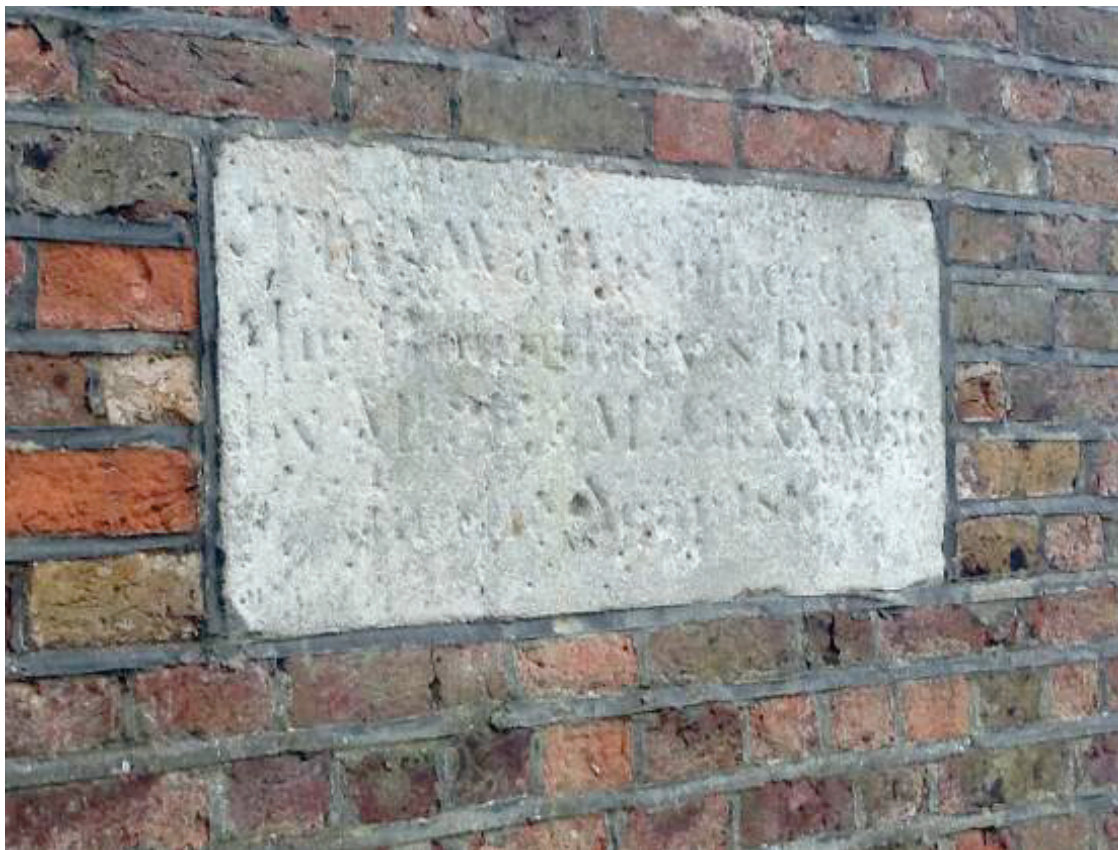
**Figure 46** The 1816 plaque of Esther Maria Cranmer, marking the boundary wall with Park Place. The plaque was re-set in the twentieth century. It is illustrated in considerably better condition in the mid twentieth century, on p.92.

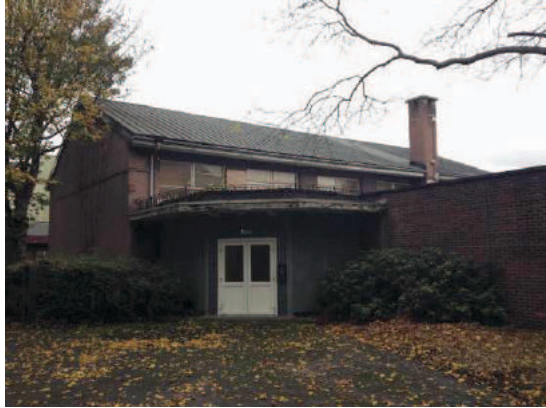
The roof of the Madeira Hall has been copper but has been coated with a bituminous felt. The walls are brick and in fair condition although there is some cracking. This cracking appears most serious in the east gable but with some cracks having deserved tell tales on the west wall. The building is a framed structure with large Crittal-style metal windows.

The design has a simple mid-20<sup>th</sup> century character. This applies particularly to the chimney which is a simple form with a square opening at the head under the cope on each side. The appearance of the building has been damaged by alterations particularly on its south side and by painting over the brickwork. There is some graffiti on the south side of the main wall.

**Figure 50** View towards Madeira Hall entrance looking north east.

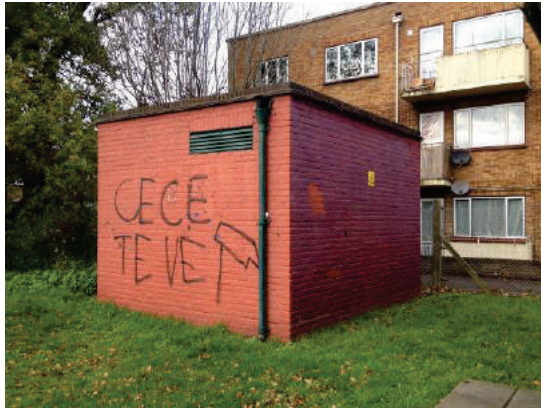
**Figure 52** Electricity substation, looking north.

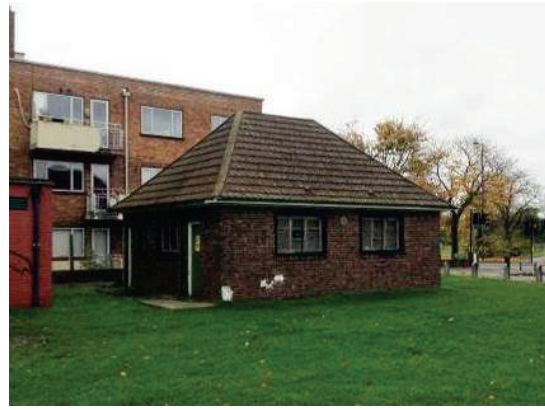
To the east is a hipped roof pavilion building built of brick which has been vandalised. On the east and north sides the gutters are damaged. There is a plaque on the building marked, "In loving remembrance of our dear David Nunoo 21<sup>st</sup> August 1979 – 30<sup>th</sup> June 2008". 1960s building: it first appears on the 1970s OS map with the sub-station.

**Figure 53** View looking north east at sports pavilion, with substation on left.

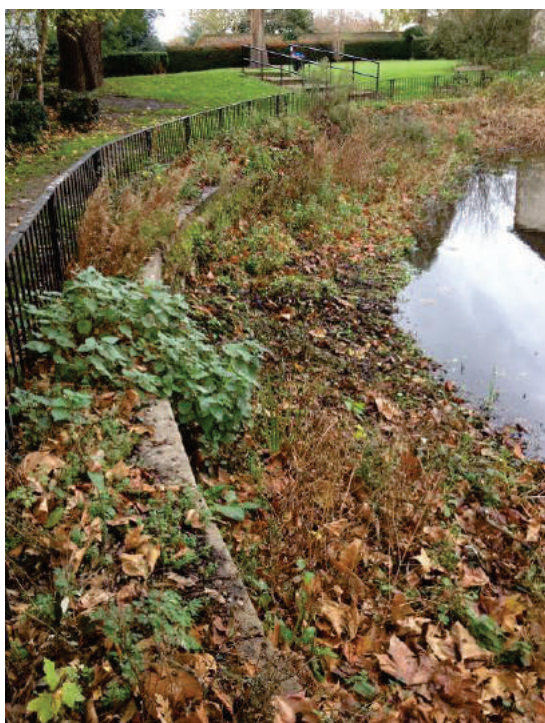
The western edge of the pond is a semi-circular wall, built of brick with a stone cope. It is a well-built structure. This seems to be the structure all around the pond. It looks in fair condition. It might need to be repointed full height and some rebedding of stones where there are trees growing through the copes.

**Figure 55** View looking north east along west pond edge.

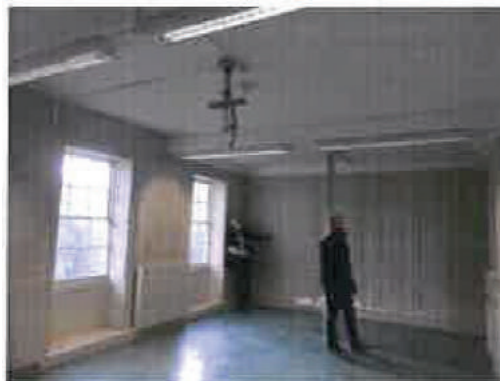
8. The floors were generally level and most rooms had coving around the edge of the ceiling. In these areas the construction was probably original but we do not know what it is or its load capacity.
9. In many of the rooms there were downstand beams which cut through the coving, suggesting that the beams were not original.

**Action** – open up the ceilings locally to the downstand beams to determine the floor construction and beam sizes. From this we can determine the floor capacity of each area of the building.

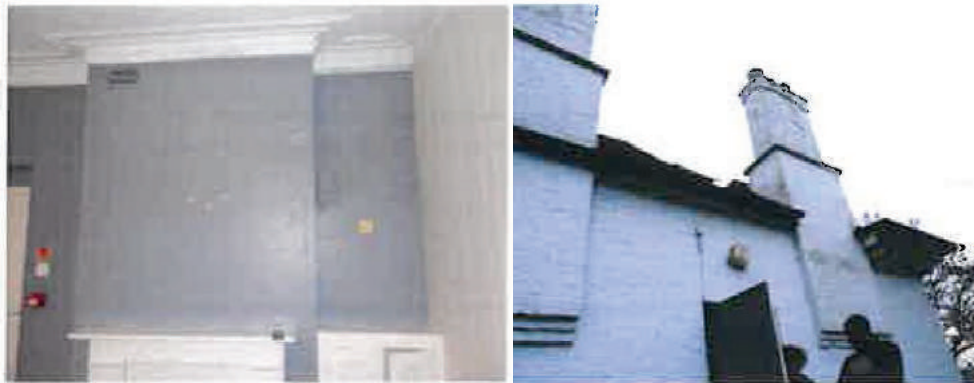
11. There was water staining to the west part of the north wall by the chimney. This staining suggested that the wall was not breathing adequately.

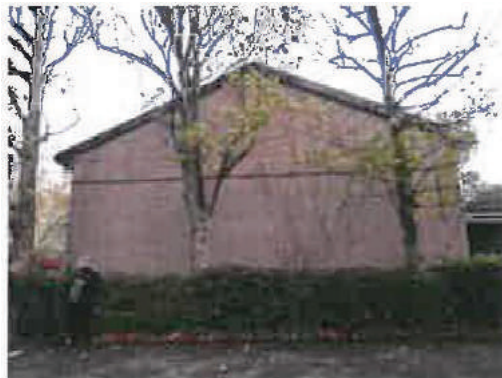
14. There was a row of trees parallel to the west wall. These trees are probably responsible for the diagonal cracking in the west wall and suggest the clay has desiccated.

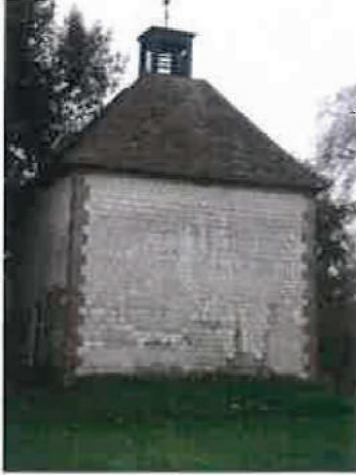
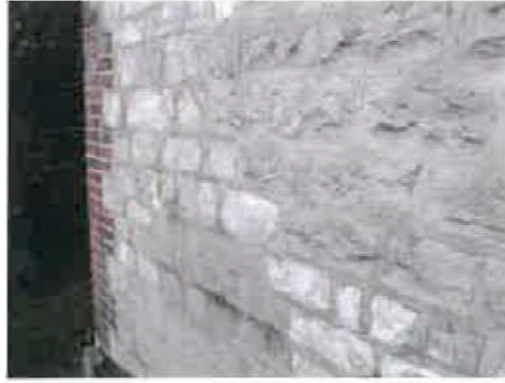
18. The walls of the Dove Cote were made of a mixture of grey clunch, white chalk, knapped flint and brick. These materials appear to have been recently repointed in a mortar which has a reasonable aggregate content but appears to use cement as the binder.

**Action** – before carrying out any work on the Dove Cote the history of the fabric should be determined. This will establish the original stones that have been used. Ideally the hard mortar should be removed and replaced with lime mortar but this could result in damage to the stonework.
